SAFER SEAS

DIGEST 2018

LESSONS LEARNED
FROM
MARINE ACCIDENT
INVESTIGATIONS

National
Transportation
Safety Board

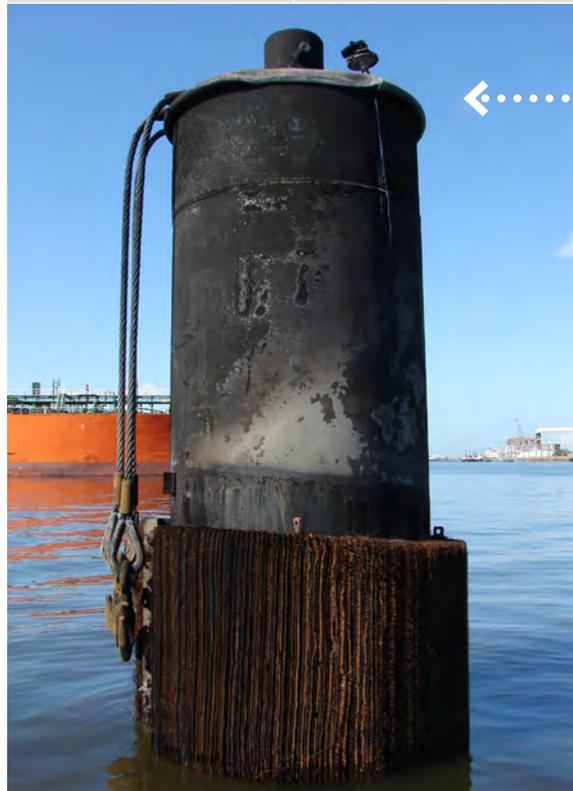
Figure 2. Dolphin no. 78B with damaged upper edge at the point of impact.

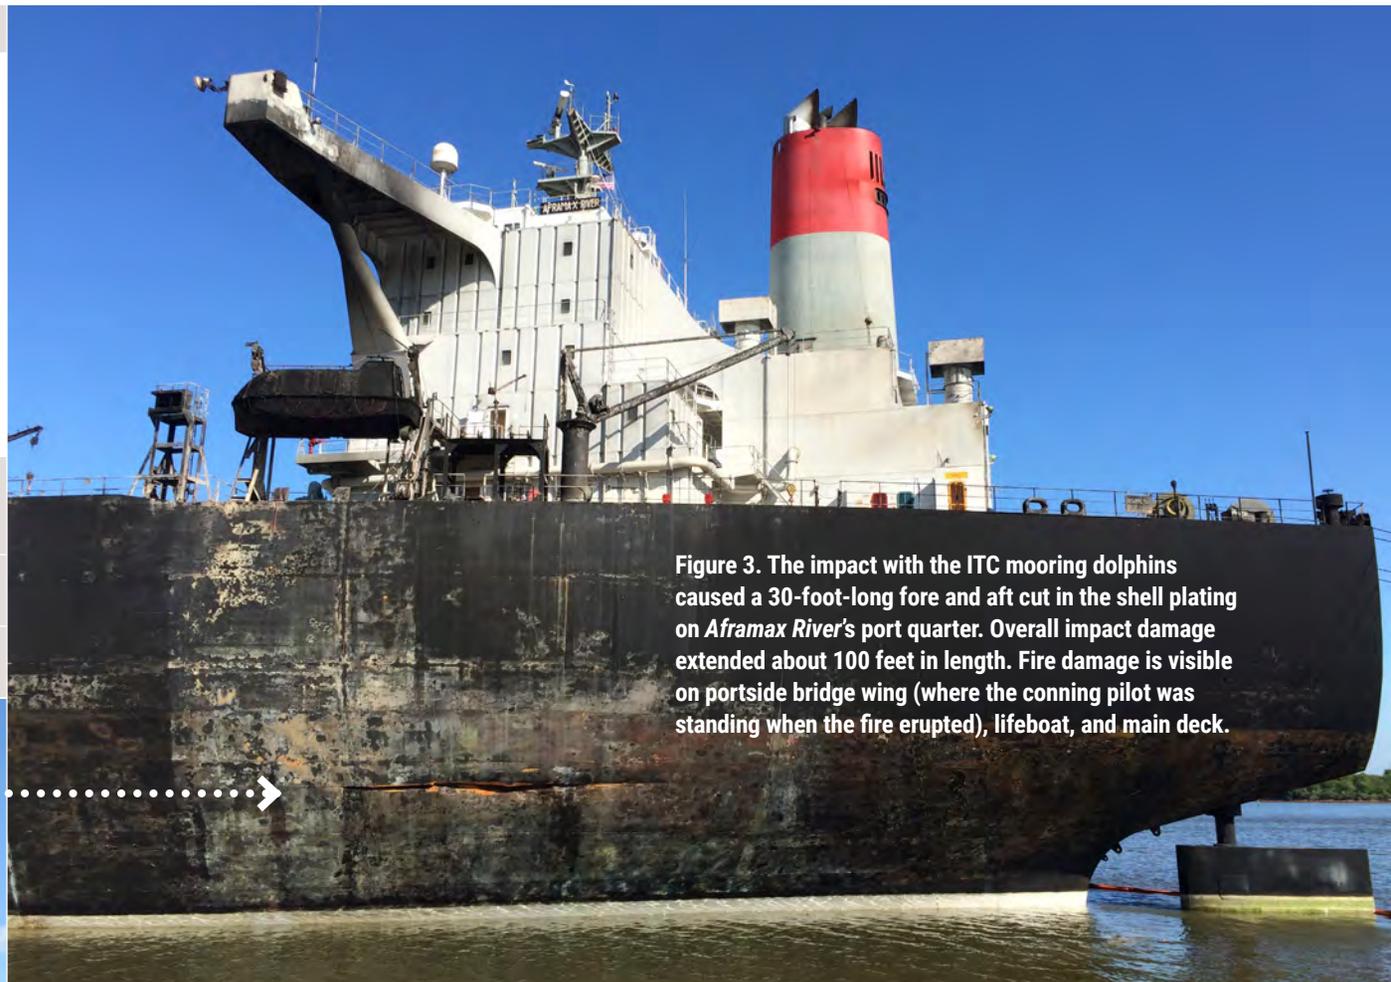
Figure 3. The impact with the ITC mooring dolphins caused a 30-foot-long fore and aft cut in the shell plating on *Aframax River*'s port quarter. Overall impact damage extended about 100 feet in length. Fire damage is visible on portside bridge wing (where the conning pilot was standing when the fire erupted), lifeboat, and main deck.

On September 6, 2016, about 0005, the tanker *Aframax River* allided with two mooring dolphins in the Houston Ship Channel near Deer Park, Texas. The allision punctured the ship's hull plating, and about 88,000 gallons of low-sulfur marine gas oil spilled into the water. The oil ignited and burned for about 45 minutes. The two onboard pilots sustained minor burns, and the property damage exceeded \$1.5 million.

According to the manufacturer of the main propulsion engine control systems, the actuator system on the *Aframax River*'s main engine governor experienced a momentary abnormality. Investigators believe that the abnormality likely resulted from an electrical and/or mechanical failure of the system, which led to loss of engine control while the vessel was engaged in astern propulsion.

The NTSB determined that the probable cause of the *Aframax River*'s allision with mooring dolphins and the subsequent fire in the waterway was a momentary abnormality of the tanker's main engine governor actuator system in responding to command inputs from the bridge.

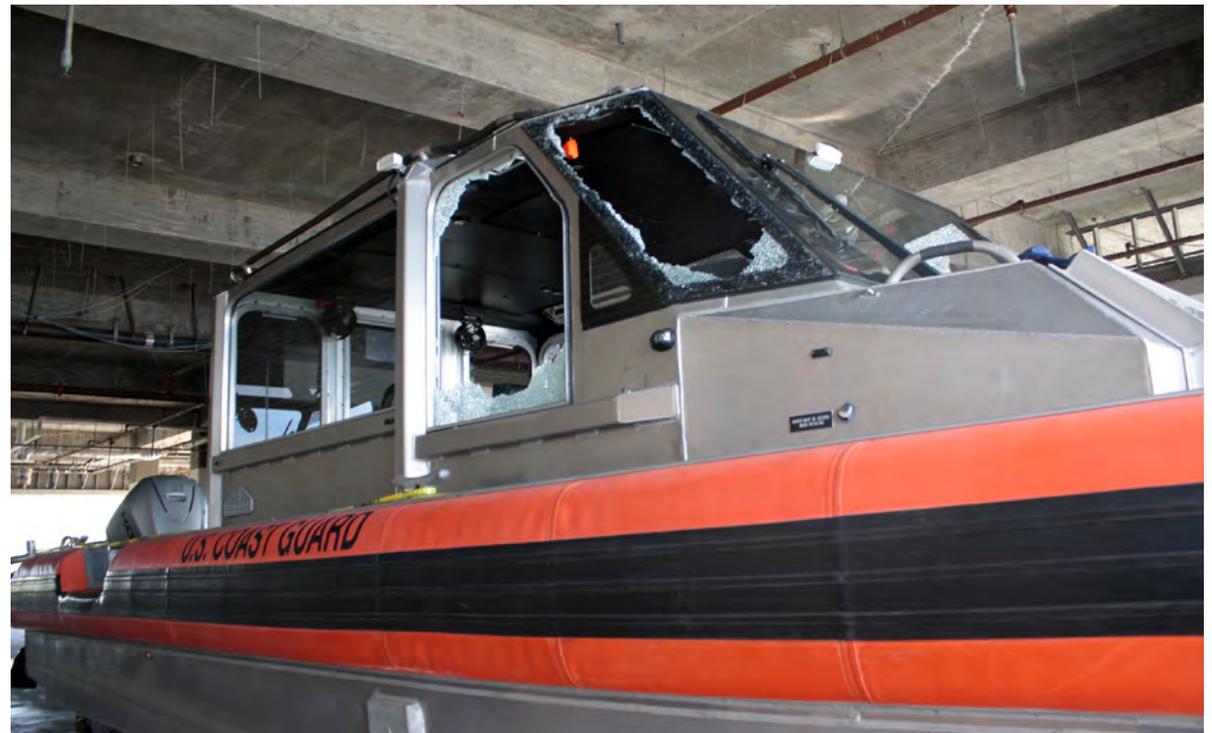
Meanwhile, the waves and the strong current caused the *CG 29113* to drift into the Highway 11 Bridge, alliding with the bridge's fendering system and concrete pilings. The initial impact was on the *CG 29113*'s starboard side. The vessel then drifted under the bridge, and its port side struck the pilings. Eventually, the crewmembers were able to restart the port engine and maneuvered the *CG 29113* to a safe area northeast of the bridge. Once away from the bridge, the crew managed to also restart the starboard engine and proceeded to the nearest ramp. The sailboat ultimately sank.

The NTSB determined that the probable cause of the towing accident involving Coast Guard response boat *CG 29113* and an adrift Vanguard sailboat was the challenging circumstances during a stern-to-stern tow in deteriorating weather conditions, which fouled the *CG 29113*'s propellers and caused a loss of propulsion. Contributing to the accident was the dilapidated state of the sailboat, which complicated the attempt to tow the vessel, which subsequently sank.

Figure 8. Starboard-side damage to the *CG 29113*.

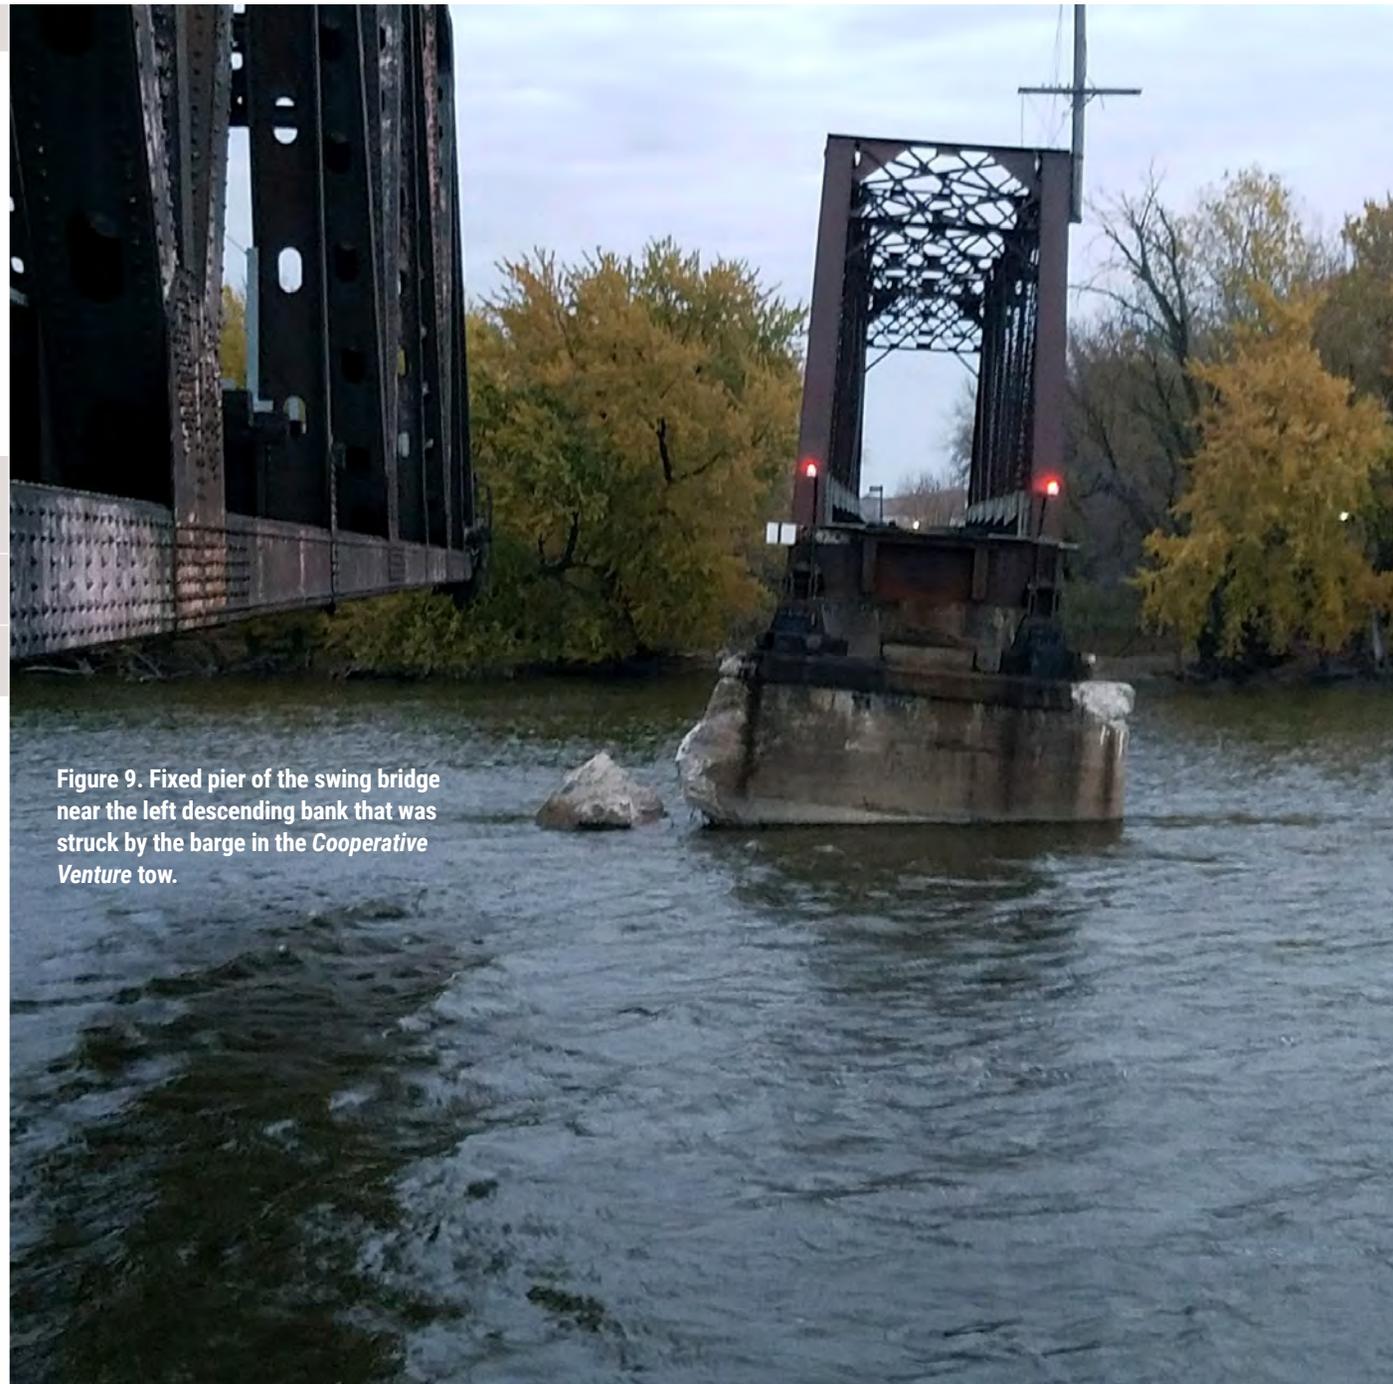
Figure 9. Fixed pier of the swing bridge near the left descending bank that was struck by the barge in the *Cooperative Venture* tow.

About 0230 on October 26, 2017, the towing vessel *Cooperative Venture*, with a crew of 10, was pushing 12 barges downbound on the Mississippi River near St. Paul, Minnesota. As the vessel approached the St. Paul Union Pacific Rail Bridge at mile 835.7, the lead barge on the port side struck a fixed pier of the swing bridge. There were no reported injuries or pollution. Damages to the bridge and barge were estimated at \$800,000 and \$153,000, respectively.

The NTSB determined that the probable cause of the allision of the towing vessel *Cooperative Venture* with the St. Paul Union Pacific Rail Bridge was the operating company's assignment of an inexperienced pilot who incorrectly positioned the tow prior to maneuvering through a turn with a following current when approaching the bridge span.

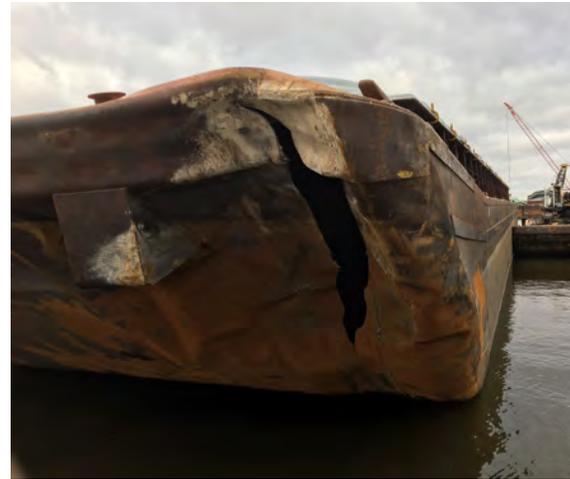
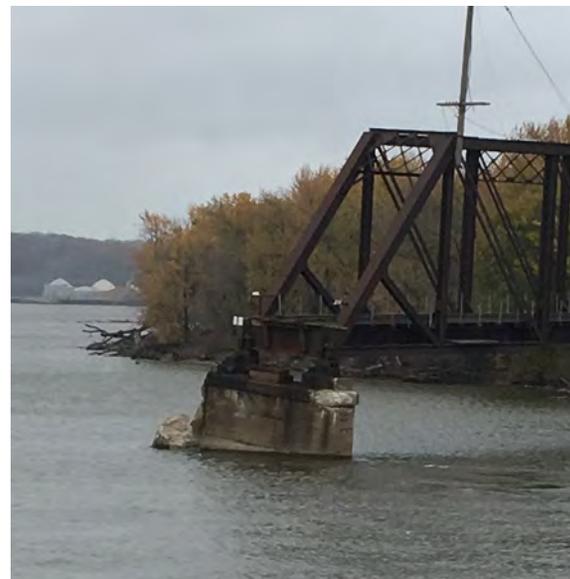
Figures 11 and 12. Damage from allision: (above) raked bow of port lead barge, ART 35157; (below) downstream view of the swing bridge's fixed pier near the left descending bank that was struck by the barge.

While transiting along the right descending bank, the pilot made several heading changes to align the vessel with the opening of the left span to pass through the bridge. As the tow approached the span, the pilot of the *Cooperative Venture* increased the vessel's speed from 3 to 4 mph and steered to starboard to increase the turn rate of the head of the tow. To help pivot the tow away from the bridge pier, the captain of the *White Rock*, which was still faced up to the center lead barge, placed his throttles to full ahead and turned his rudders hard to starboard. The pilot, nonetheless, was unable to properly navigate the *Cooperative Venture* tow, and at 0230, the bow of the lead barge on the port side, ART 35157, allided with the east fixed pier of the swing bridge, puncturing the barge's bow and damaging the concrete pier.

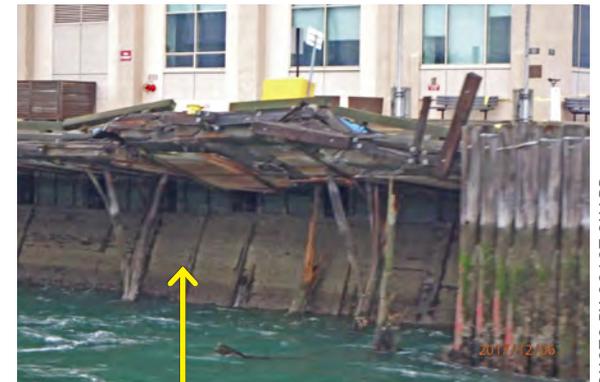
Figures 15 and 16. Above, damage to Black Falcon pier; below, approximate location and scale view of Helsinki Bridge alongside Conley Terminal and vessel's drift after breakaway. Also shown are area of terminal under construction and damaged pier at Black Falcon Terminal. (Satellite image shows a work barge engaged in repair of pier.) BACKGROUND FROM GOOGLE EARTH

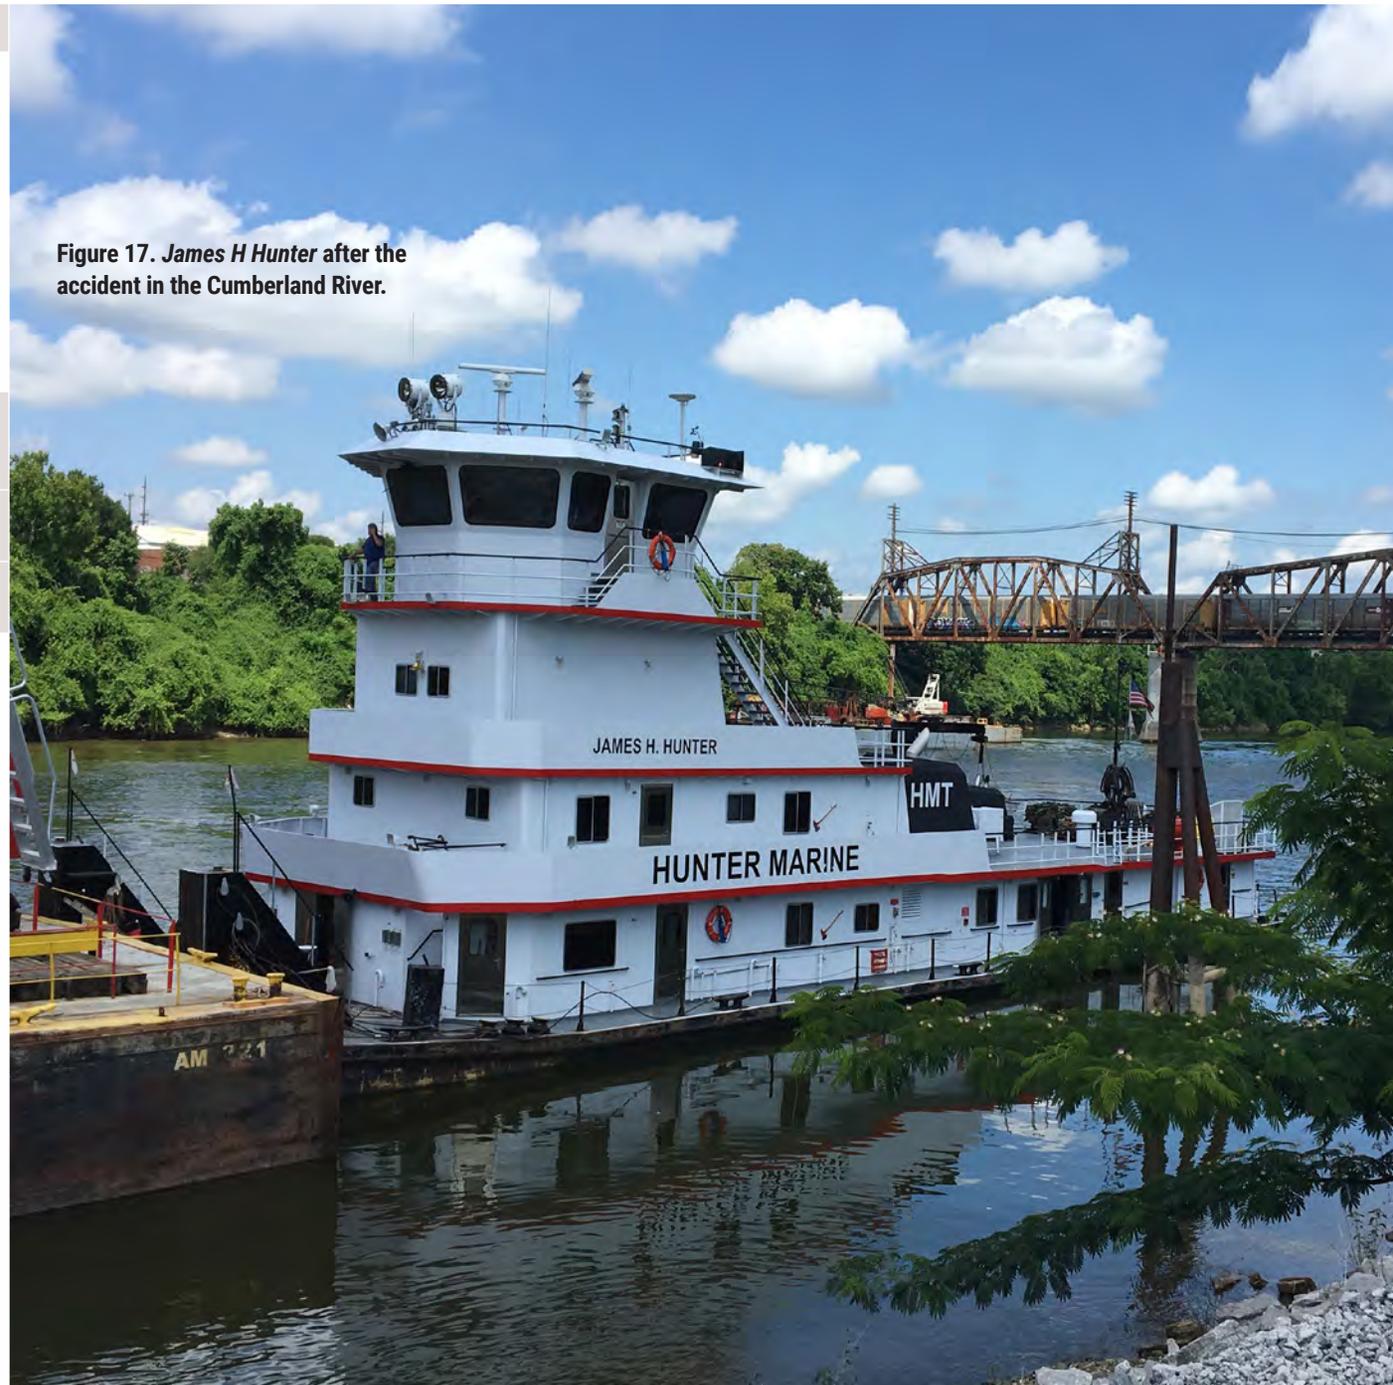
Figure 17. *James H Hunter* after the accident in the Cumberland River.

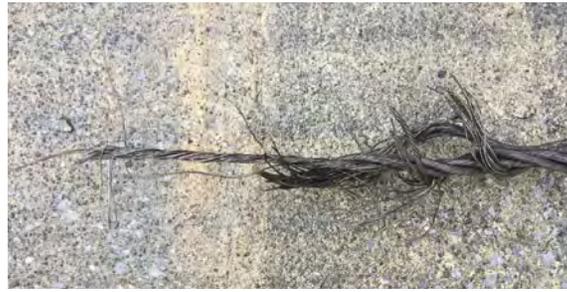
Figure 19. Strands on wire rigging that was recovered by investigators indicated that the wires had fractured while in tension.

operator input. However, the captain stated that “the pilot steered a little hard” and that overcorrecting while operating in high water moving at about 5 mph put too much stress on the coupling. Seconds later, the pilot and the captain noticed that the port steering coupling between *PBM 403* (the face-up barge) and *PB 2013* (the middle barge) parted. The captain immediately notified the deck crew by radio that the barges were coming loose and put the vessel in astern propulsion; it was stopped about 2251. The pilot notified nearby vessels of the breakaway barges by VHF radio.

The NTSB determined that the probable cause of the allision of the *James H Hunter* tow with the dock and fire boat was the practice of using single barge couplings in high-water conditions, which resulted in the parting of a steering coupling after rudder input to counteract the strong current.

In high-water conditions, which often include strong currents, precautions should be taken to mitigate the risk of losing the tow. Examples of mitigating measures include doubling up on couplings and/or reducing the length of the tow.

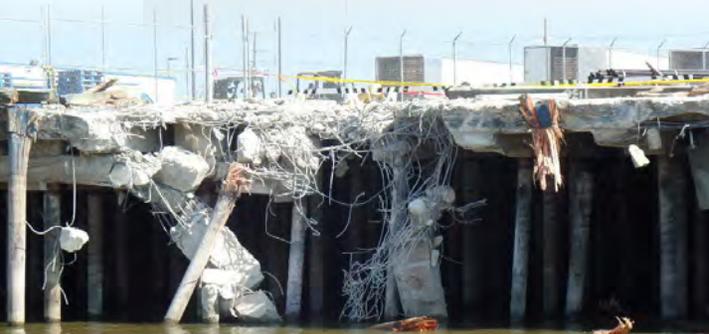
Figure 23. Damage to the Nashville Avenue Wharf where the bulk carrier left an impression of its bow.

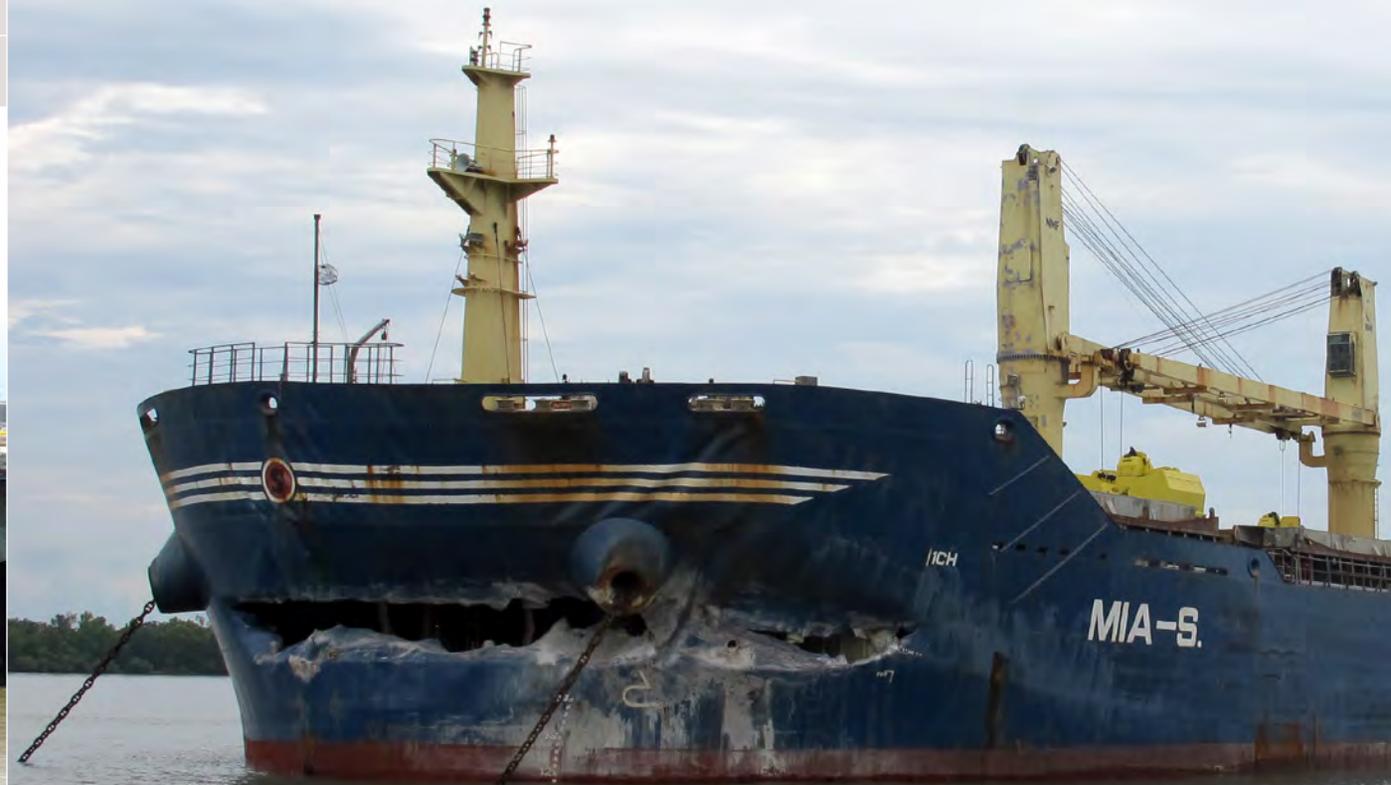
Figure 24. Bow damage sustained by the *Mia S*.

The NTSB determined that the probable cause of the allision of the bulk carrier *Mia S* with the Nashville Avenue Wharf was the chief engineer's poor communication to the master regarding the potential for additional protective engine slowdowns at orders above dead slow ahead, and the master and pilot's decision to proceed at full ahead, which resulted in a reduction in engine speed and subsequent loss of maneuverability while navigating through a sharp river bend.

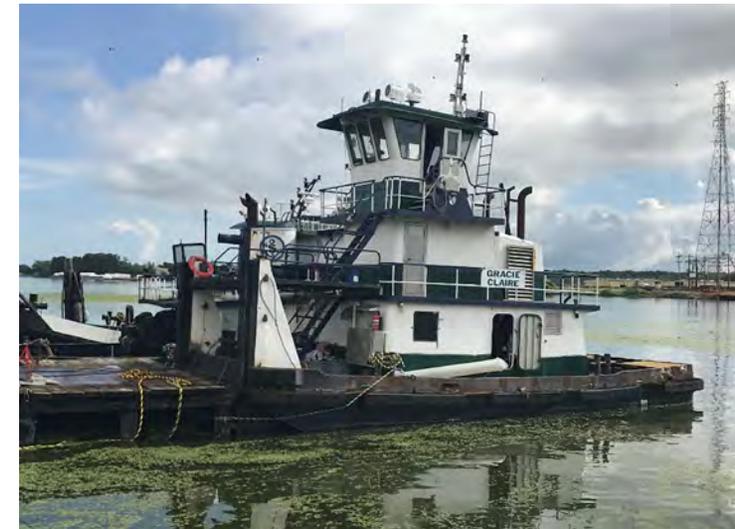
The NTSB determined that the probable cause of the capsizing and sinking of the *Gracie Claire* was the towing vessel's decreased stability and freeboard due to undetected flooding through a hull leak in the rudder compartment, which made the vessel susceptible to the adverse effects of boarding water from the wake of a passing vessel.

Figure 36. *Gracie Claire* moored for repair following the sinking. PHOTO COURTESY OF TRIPLE S MARINE

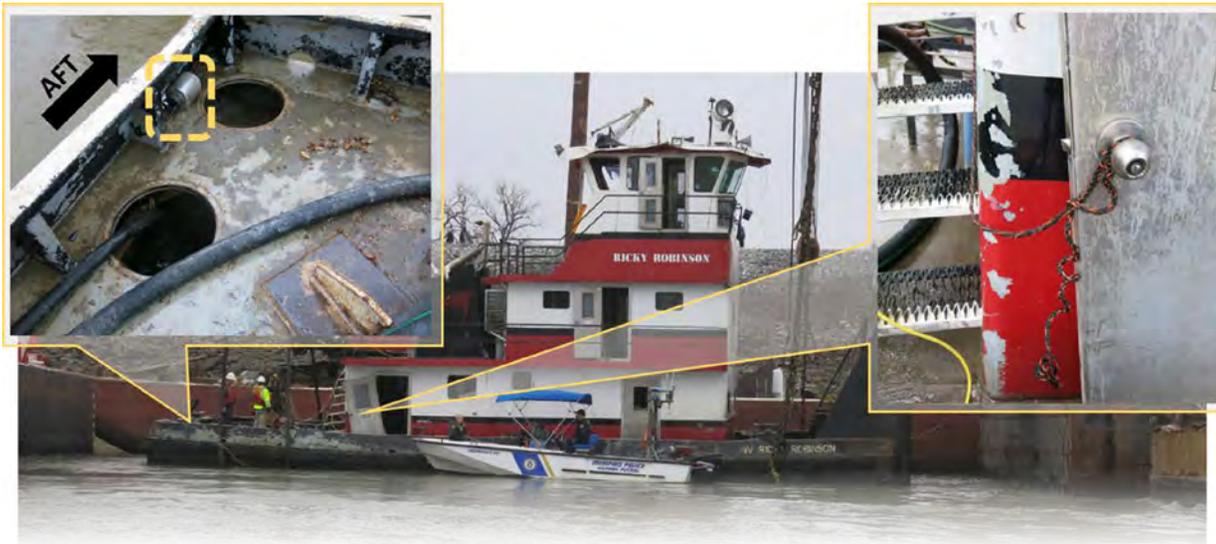
Figure 41. *Ricky Robinson* post-salvage. Two inset photos show (at left) both aft voids missing hatch covers, with a yellow square highlighting where the submersible pump was found, and (at right) the open starboard engine room door that was tied off to the stairs.

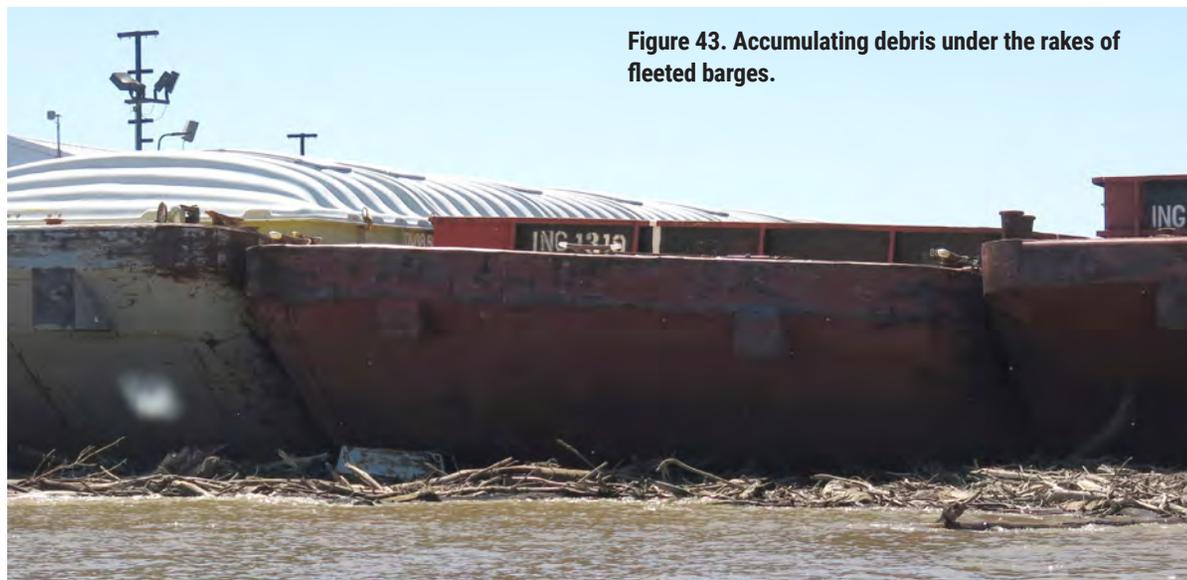
Figure 43. Accumulating debris under the rakes of fleeted barges.

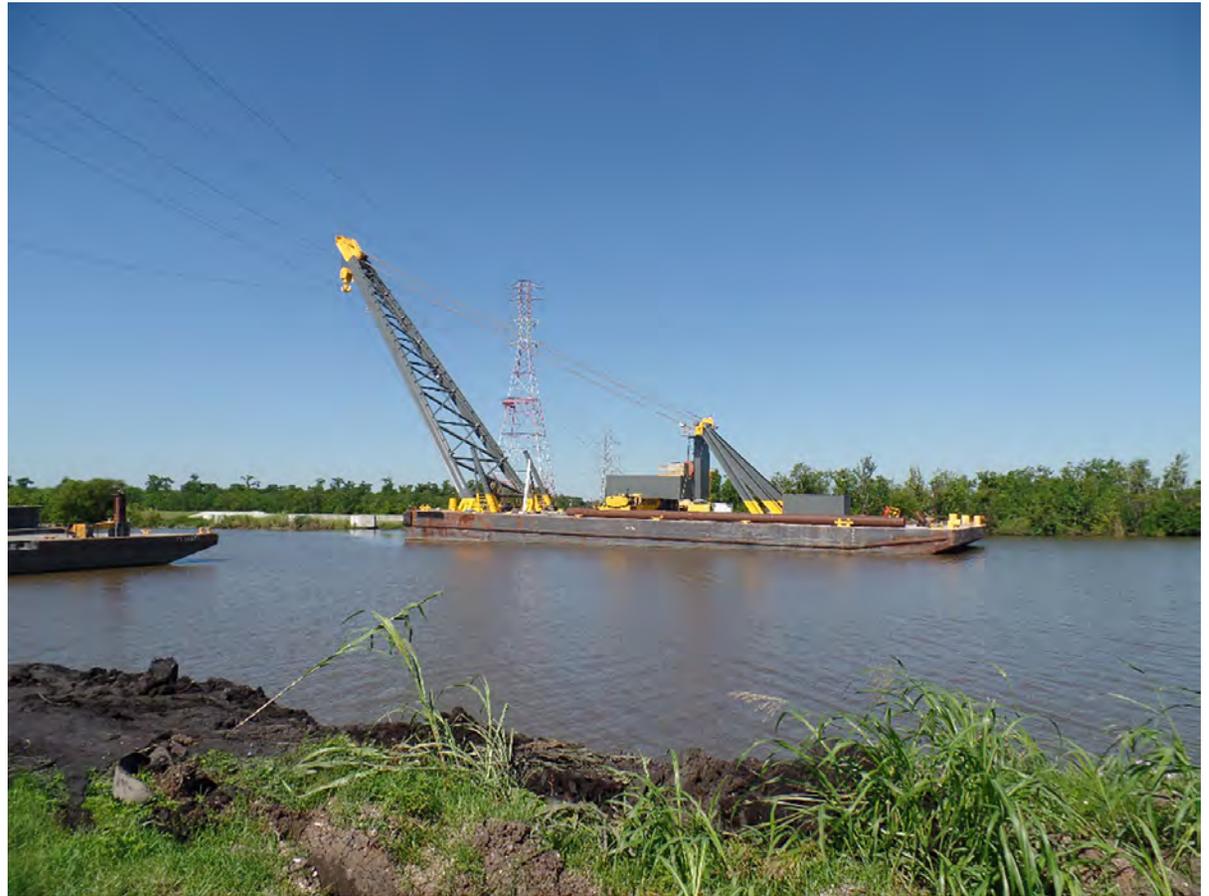
Figure 45. *Troy McKinney's* crane resting against power lines. PHOTO BY COAST GUARD

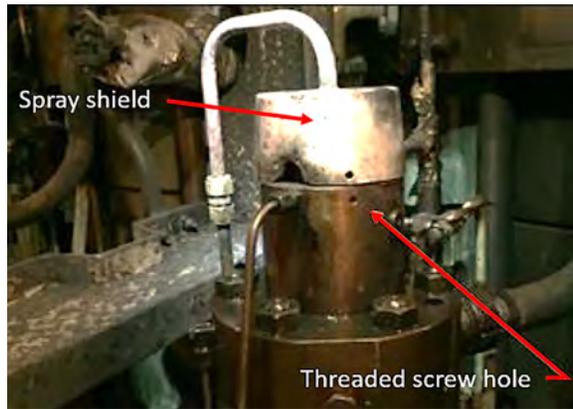
Figure 49. Inboard view of the no. 6 cylinder fuel pump and top cover postaccident, with the spray shield slightly elevated to illustrate alignment of fastener holes.

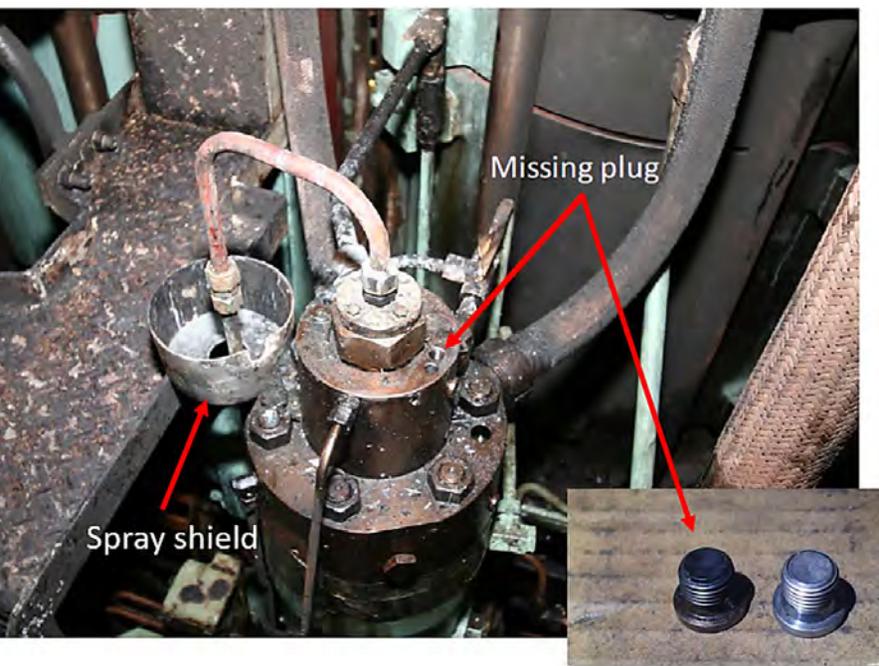
Figure 50. Fuel pump housing and top cover for the no. 6 cylinder, with missing pipe plug. The lower-right image shows the dislodged pipe plug (left) next to a new unused plug.

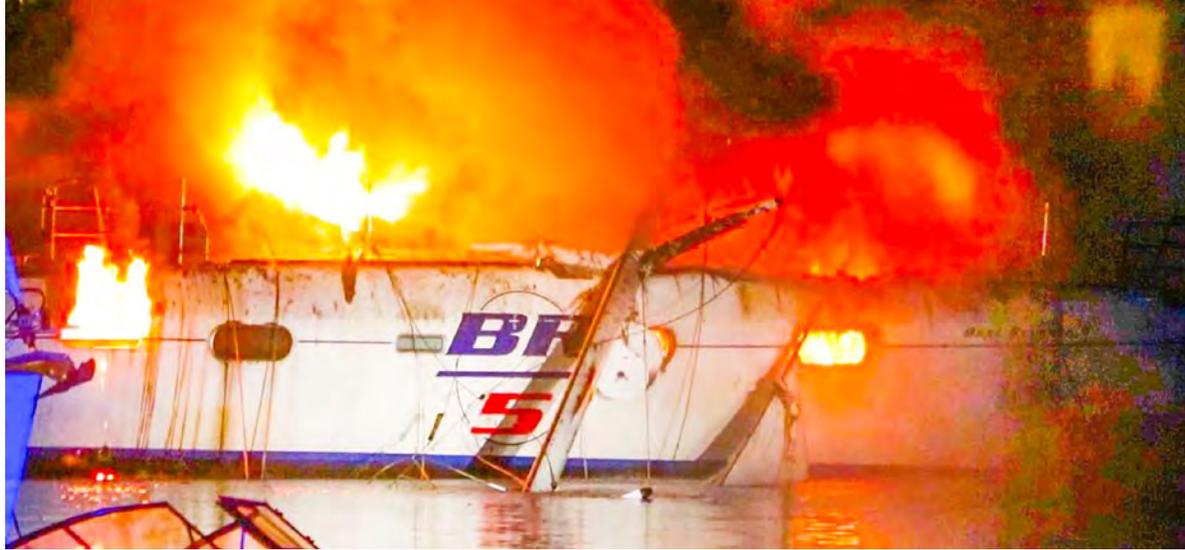
Figure 52. *Best Revenge 5* on fire at the dock. PHOTO COURTESY OF SATELLITE NEWS SERVICE

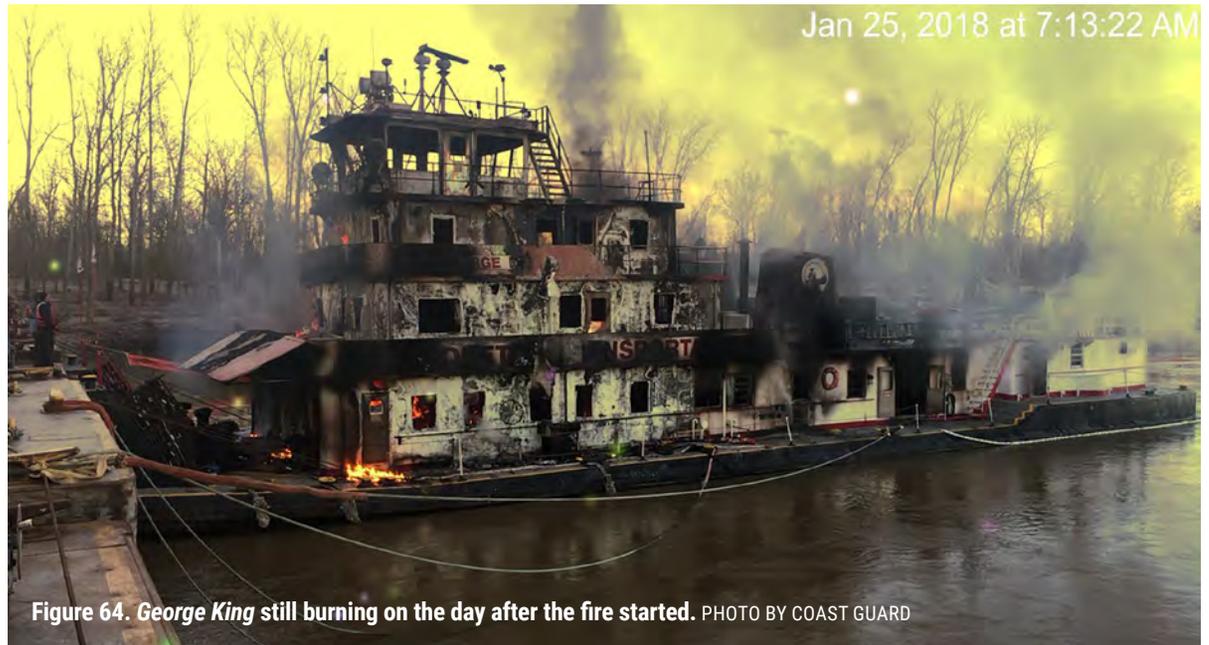
Figure 64. *George King* still burning on the day after the fire started. PHOTO BY COAST GUARD

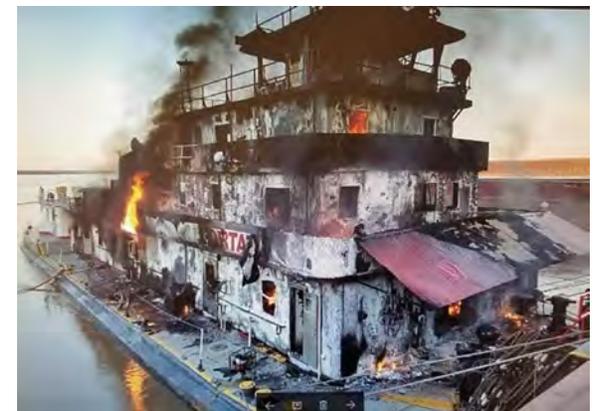
Figure 67. Another view of the burning vessel the morning after the fire.

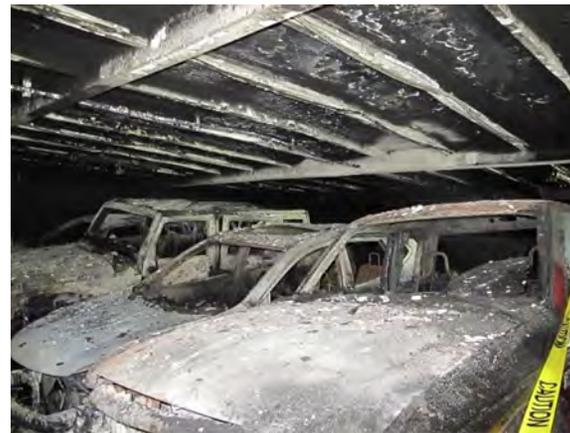
Figure 70. Damaged cars on the garage deck.

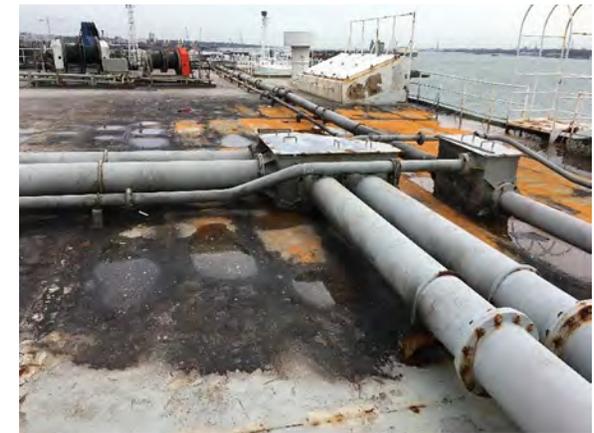
Figures 71 and 72. Above, damage to the top deck above the garage. Below, exterior bulkhead on the port side of the garage while looking aft.

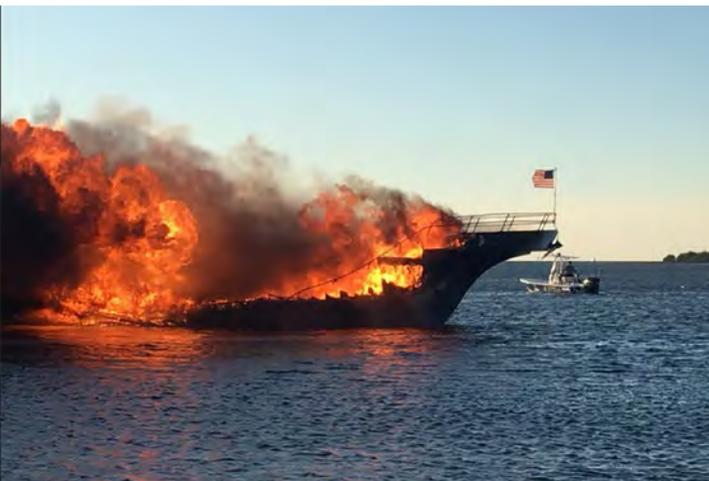
Figure 75. *Island Lady* engulfed in flames.
PHOTO COURTESY OF COUNTY SHERIFF'S OFFICE

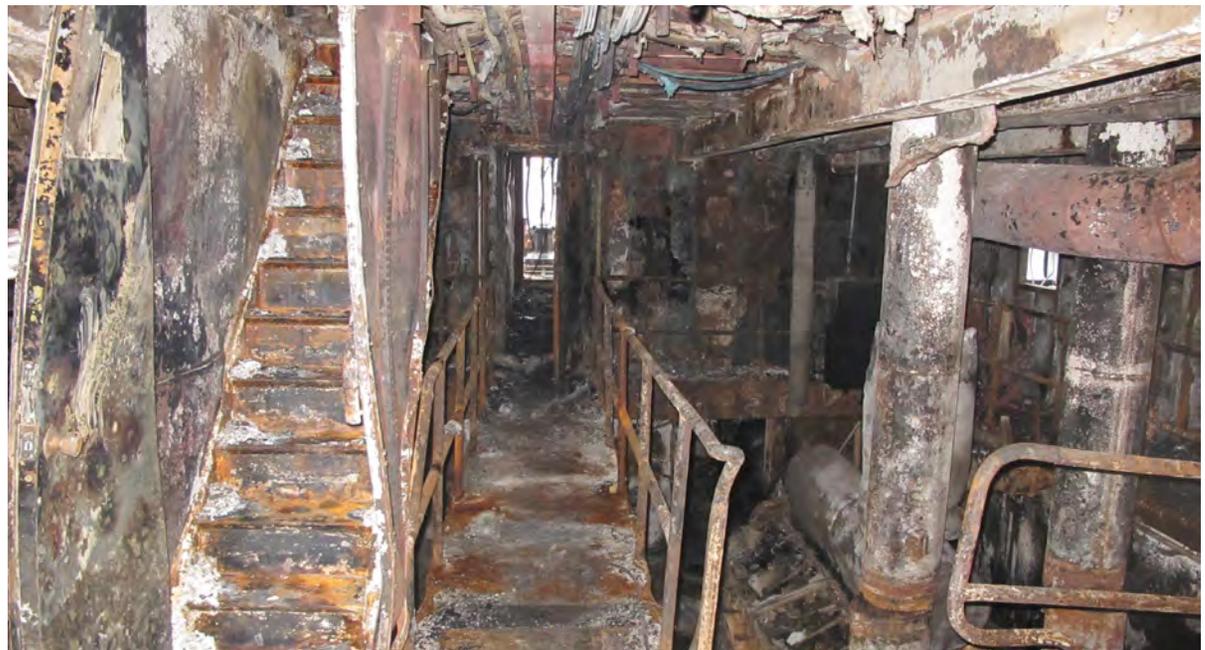
Figure 79. Fire damage of the engine room's upper level (looking forward).

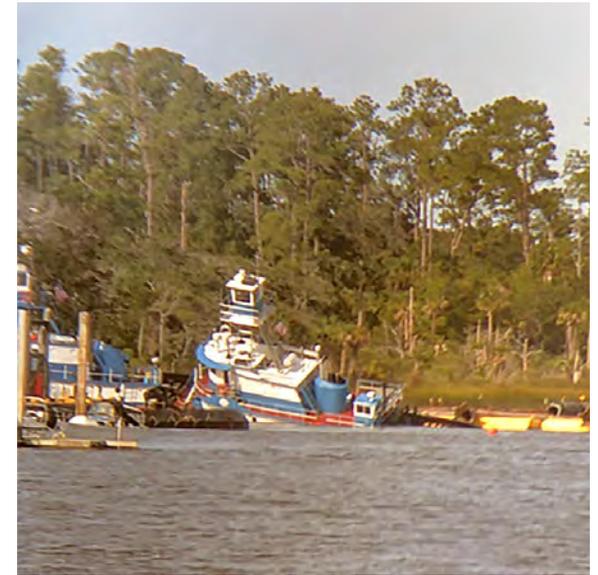
Figure 83. *Atlantic Raider* aground on the shallows of the west side of the Blount Island Channel. Note that the port quarter is under water up to the lower wheelhouse deck.

According to a company representative, the *Atlantic Raider* did not normally have 26,000 gallons of fuel on board as it did the morning of the accident. At that condition, the draft of the vessel would have been deeper than normal—about 10.5 feet—putting the hull fracture at the waterline. Water likely entered the rudder compartment through the hull fracture and increased the draft by the stern, which would have caused the flooding rate to increase. About 5 hours later, the vessel began to sink by the port quarter.

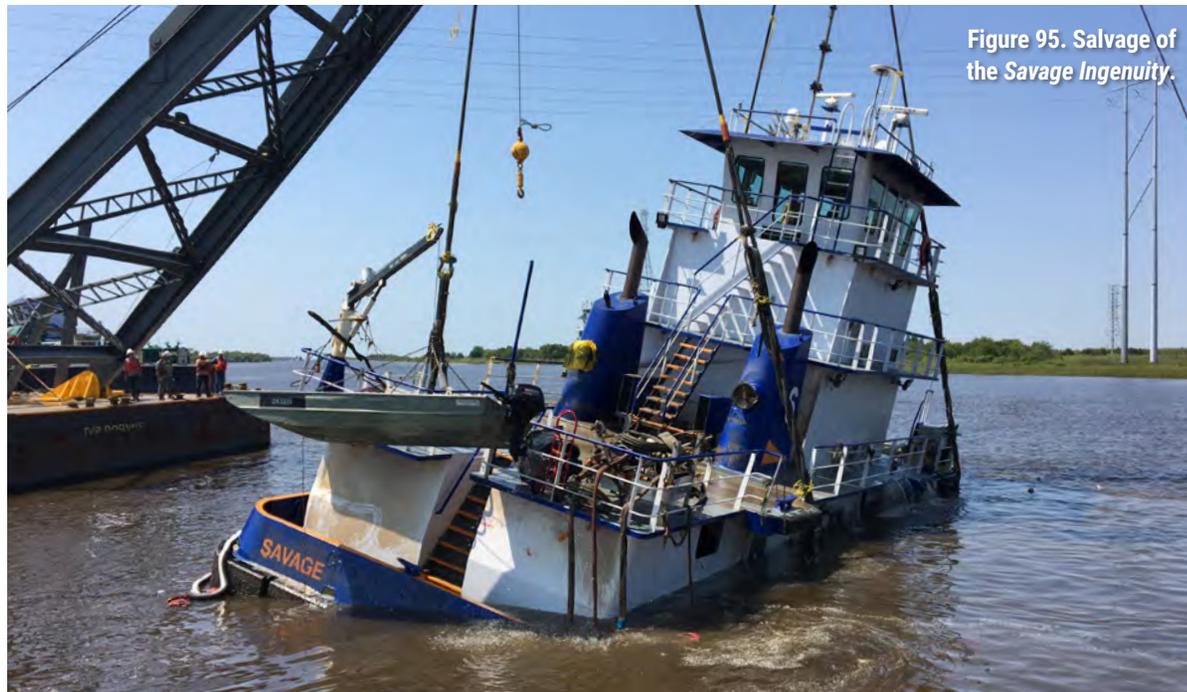
Figure 95. Salvage of the *Savage Ingenuity*.

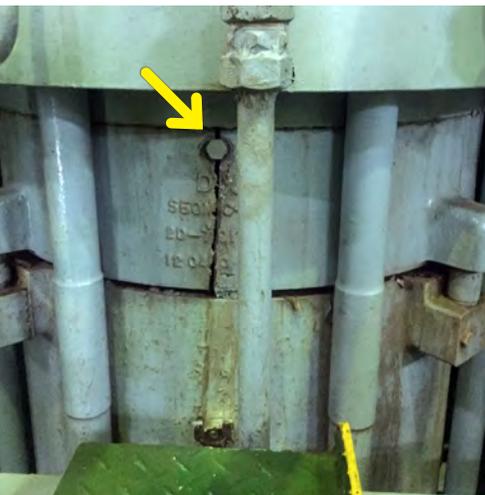
Figure 100. Cracked cooling jacket on main engine no. 3 cylinder, postaccident. Arrow identifies one of four hex head securing bolts for the jacket cover.

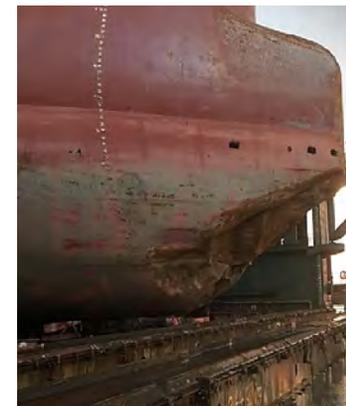
Figure 101. Damage to *Nenita*'s bulbous bow, starboard side.
