SAFER SEAS

DIGEST 2018

LESSONS LEARNED
FROM
MARINE ACCIDENT
INVESTIGATIONS

National
Transportation
Safety Board

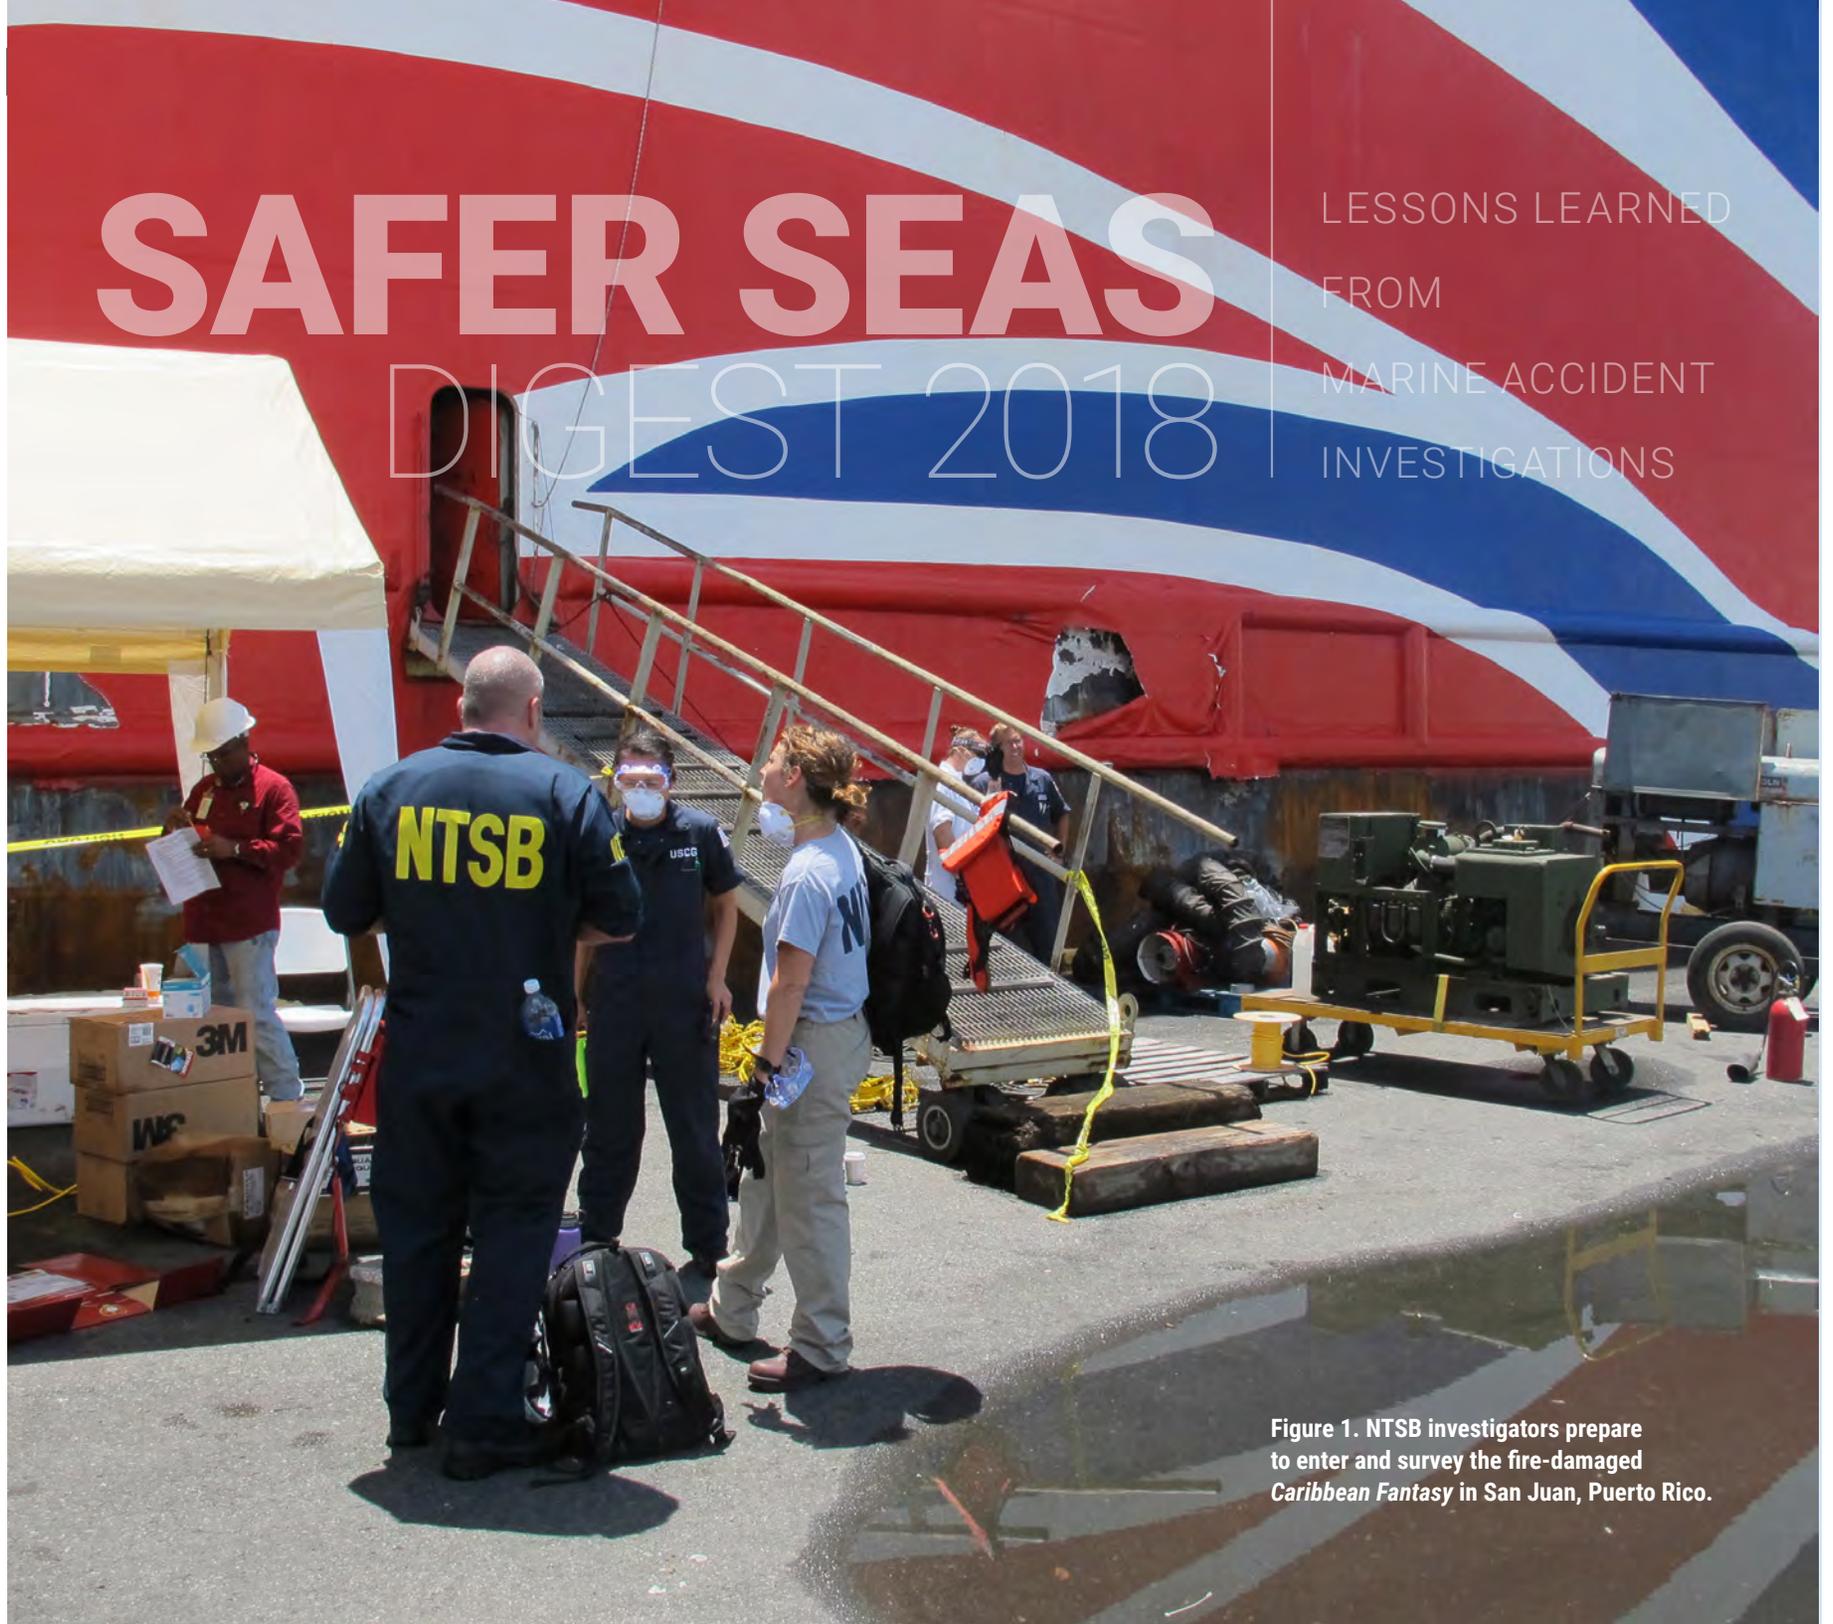
Figure 1. NTSB investigators prepare to enter and survey the fire-damaged *Caribbean Fantasy* in San Juan, Puerto Rico.

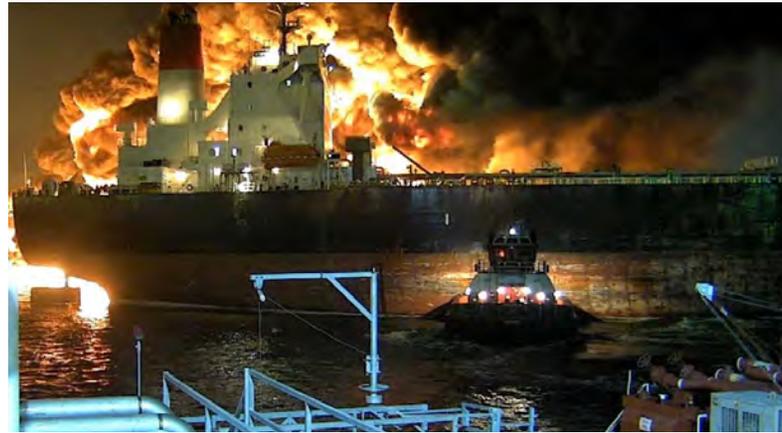
Figure 4. *Aframax River* after the allision with dolphin no. 78B. Tugboat *David B* is in the foreground rendering assistance.

According to the manufacturer of the main propulsion engine control systems, the actuator system on the *Aframax River*'s main engine governor experienced a momentary abnormality. Investigators believe that the abnormality likely resulted from an electrical and/or mechanical failure of the system, which led to loss of engine control while the vessel was engaged in astern propulsion.

The NTSB determined that the probable cause of the *Aframax River*'s allision with mooring dolphins and the subsequent fire in the waterway was a momentary abnormality of the tanker's main engine governor actuator system in responding to command inputs from the bridge.

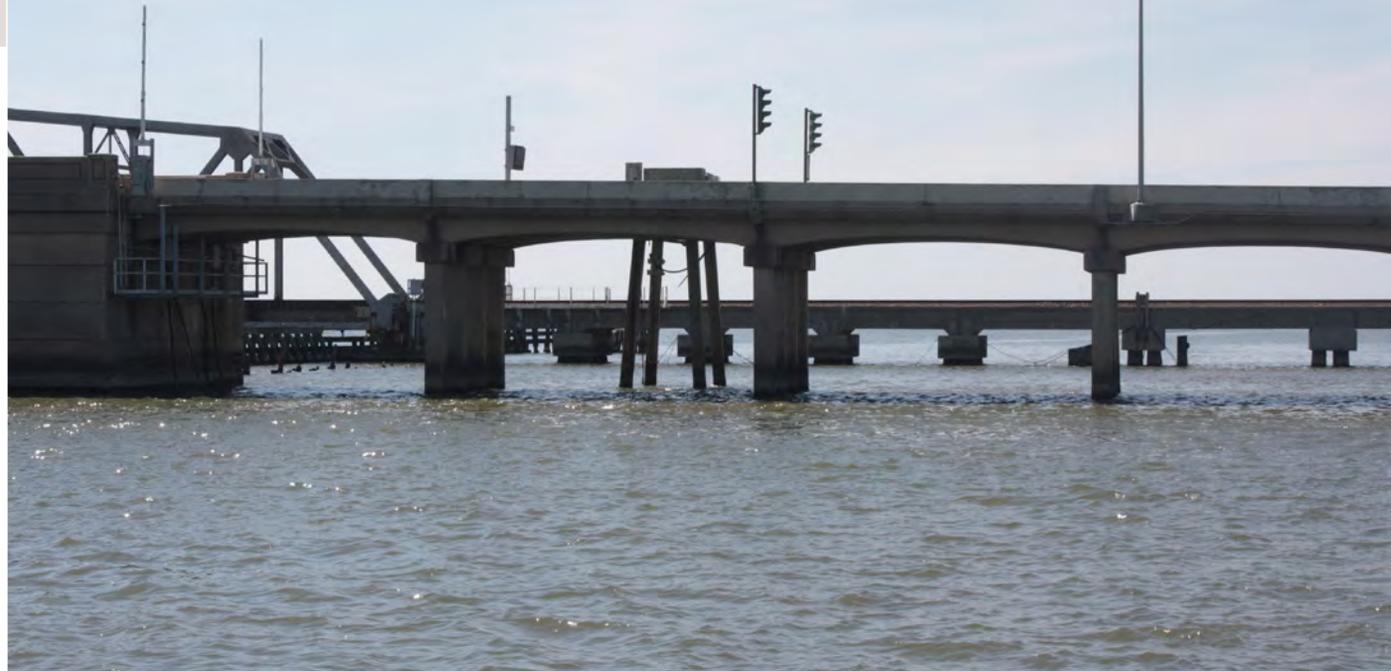
Figure 5. Highway 11 Bridge over Lake Pontchartrain in the vicinity of the accident site.

Meanwhile, the waves and the strong current caused the *CG 29113* to drift into the Highway 11 Bridge, alliding with the bridge's fendering system and concrete pilings. The initial impact was on the *CG 29113*'s starboard side. The vessel then drifted under the bridge, and its port side struck the pilings. Eventually, the crewmembers were able to restart the port engine and maneuvered the *CG 29113* to a safe area northeast of the bridge. Once away from the bridge, the crew managed to also restart the starboard engine and proceeded to the nearest ramp. The sailboat ultimately sank.

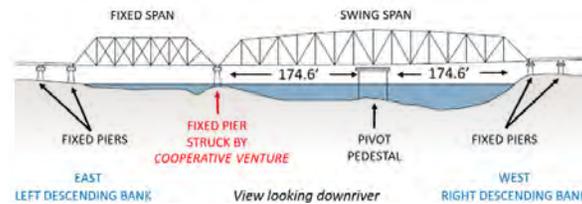
Figure 10. St. Paul Union Pacific Rail Bridge in closed position, as approached by *Cooperative Venture*.

The NTSB determined that the probable cause of the allision of the towing vessel *Cooperative Venture* with the St. Paul Union Pacific Rail Bridge was the operating company's assignment of an inexperienced pilot who incorrectly positioned the tow prior to maneuvering through a turn with a following current when approaching the bridge span.

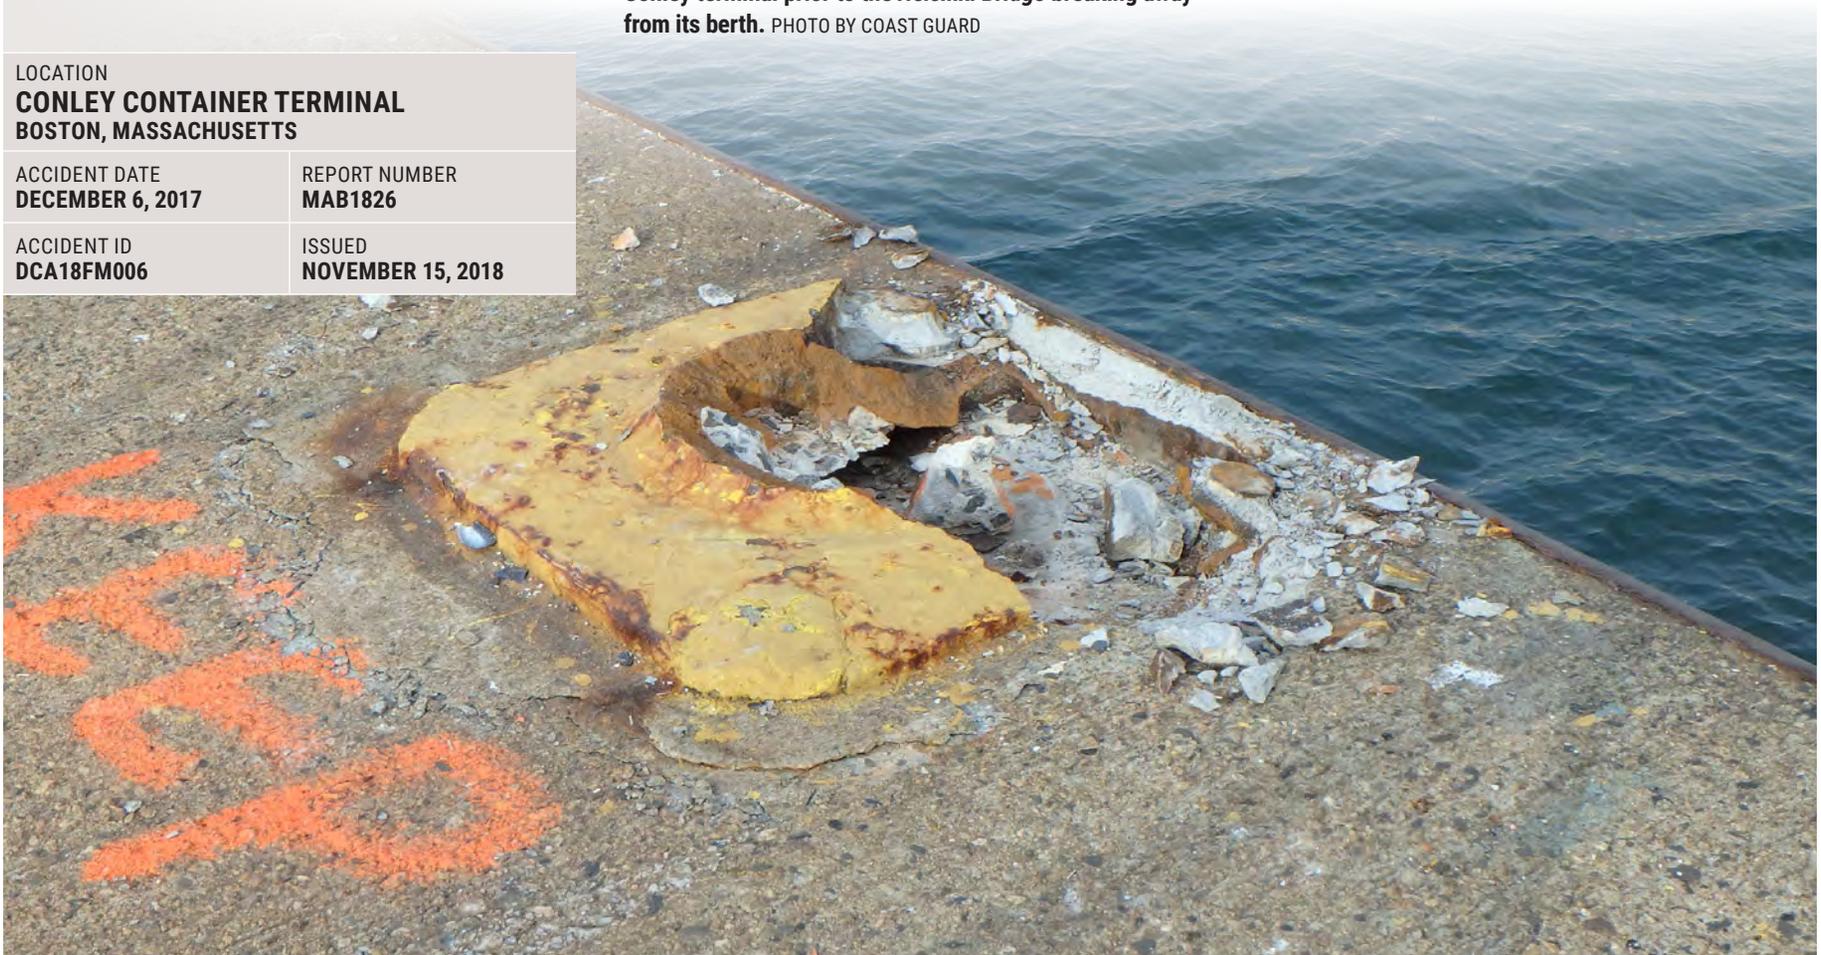
Figure 13. Remaining base of bollard that failed at the Conley terminal prior to the *Helsinki Bridge* breaking away from its berth. PHOTO BY COAST GUARD

Later that night, the forecasted high winds arrived. At 0003, the winds caused the bollard to which the five head lines were secured to be torn off its base. The *Helsinki Bridge* began to drift away from the container terminal in a northerly direction. In just a few minutes, the remaining seven lines also parted, in succession from forward to aft, as the ship continued to be blown out into the channel to almost a 45-degree angle from its berth. After learning of the breakaway, the master ordered all deckhands to their respective mooring stations. He also ordered the crew to walk out the starboard anchor to “one shackle above the water.” The ship continued to swing, and at 0006, its bulbous bow struck the Black Falcon pier.

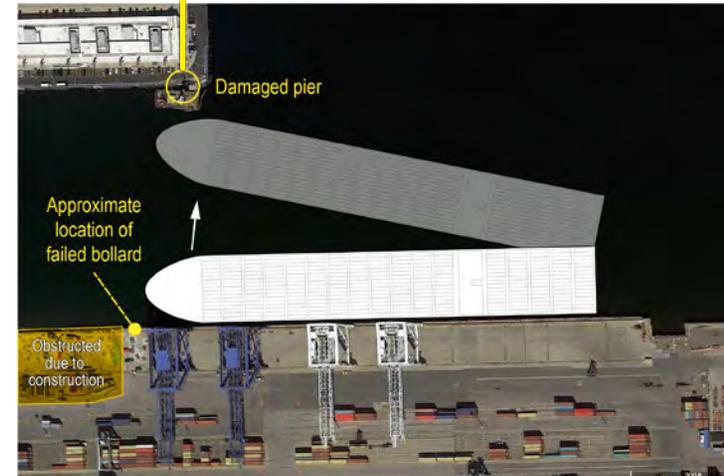
The NTSB determined that the probable cause of the breakaway of the containership *Helsinki Bridge* and subsequent allision with the Black Falcon Cruise Terminal was the failure of Massachusetts Port Authority to provide suitable berthing arrangements during ongoing construction at the Conley Container Terminal, which resulted in the overloading and failure of a single mooring bollard. Contributing to the accident was the lack of preparation by the vessel's master, who was aware of the less than suitable mooring arrangements and the deteriorating weather forecast but took no mitigating action to address the situation.

Figures 15 and 16. Above, damage to Black Falcon pier; below, approximate location and scale view of Helsinki Bridge alongside Conley Terminal and vessel's drift after breakaway. Also shown are area of terminal under construction and damaged pier at Black Falcon Terminal. (Satellite image shows a work barge engaged in repair of pier.) BACKGROUND FROM GOOGLE EARTH

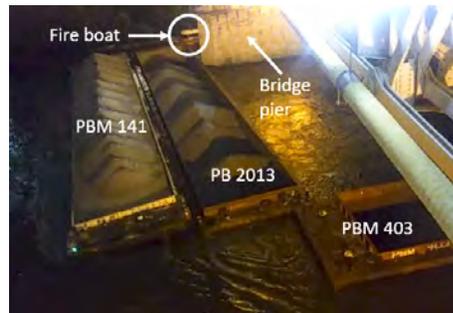
Figure 18. The three barges, fire boat, and pedestrian bridge pier about 2254.
IMAGE TAKEN FROM WITNESS VIDEO

The NTSB determined that the probable cause of the allision of the *James H Hunter* tow with the dock and fire boat was the practice of using single barge couplings in high-water conditions, which resulted in the parting of a steering coupling after rudder input to counteract the strong current.

In high-water conditions, which often include strong currents, precautions should be taken to mitigate the risk of losing the tow. Examples of mitigating measures include doubling up on couplings and/or reducing the length of the tow.

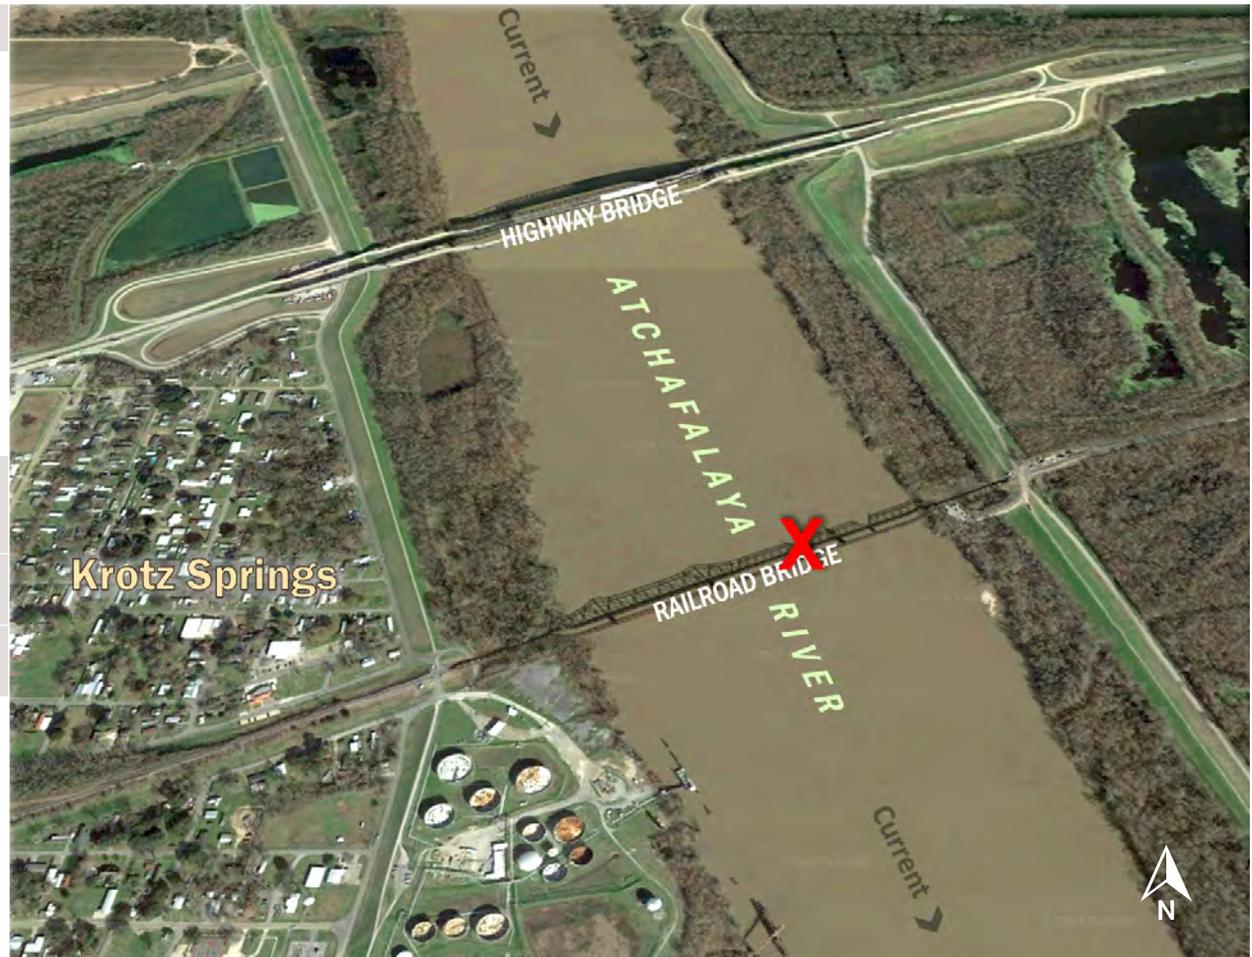
Figure 20. Marked by a red X, the site where the *Marguerite L. Terral* tow allided with a pier of the railroad bridge on the Atchafalaya River in Krotz Springs, Louisiana.

The NTSB determined that the probable cause of the allision of the *Marguerite L. Terral* tow with the Krotz Springs Railroad Bridge was the bridge tender's delay in providing a timely opening of the drawspan, as requested, due to distraction by his other duties. Contributing to the accident was the pilot's failure to properly compensate for the current during the approach to the bridge.

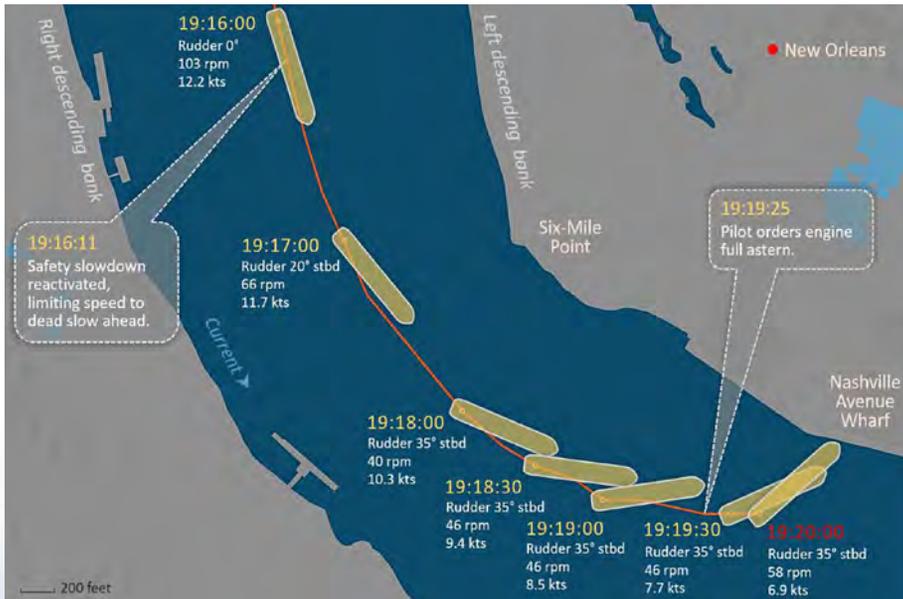
Figure 25. Trackline of the *Mia S* over the last 4 minutes leading up to the accident shows changes in the vessel's heading and speed over ground following an engine slowdown.

As the alarms sounded, the engineers attempted to restore the engine's full maneuvering capabilities. The chief engineer later told investigators that a fuel pump for one of the six engine cylinders was not providing fuel. Over the next 20 minutes, the slowdown alarm was acknowledged by the master each time it activated. An engine order of full ahead was recorded at 1729, but as the engine's speed increased to 100 rpm, another safety slowdown occurred. In slowdown mode, the engine was limited to dead slow ahead, which was 5 knots at 45 rpm.

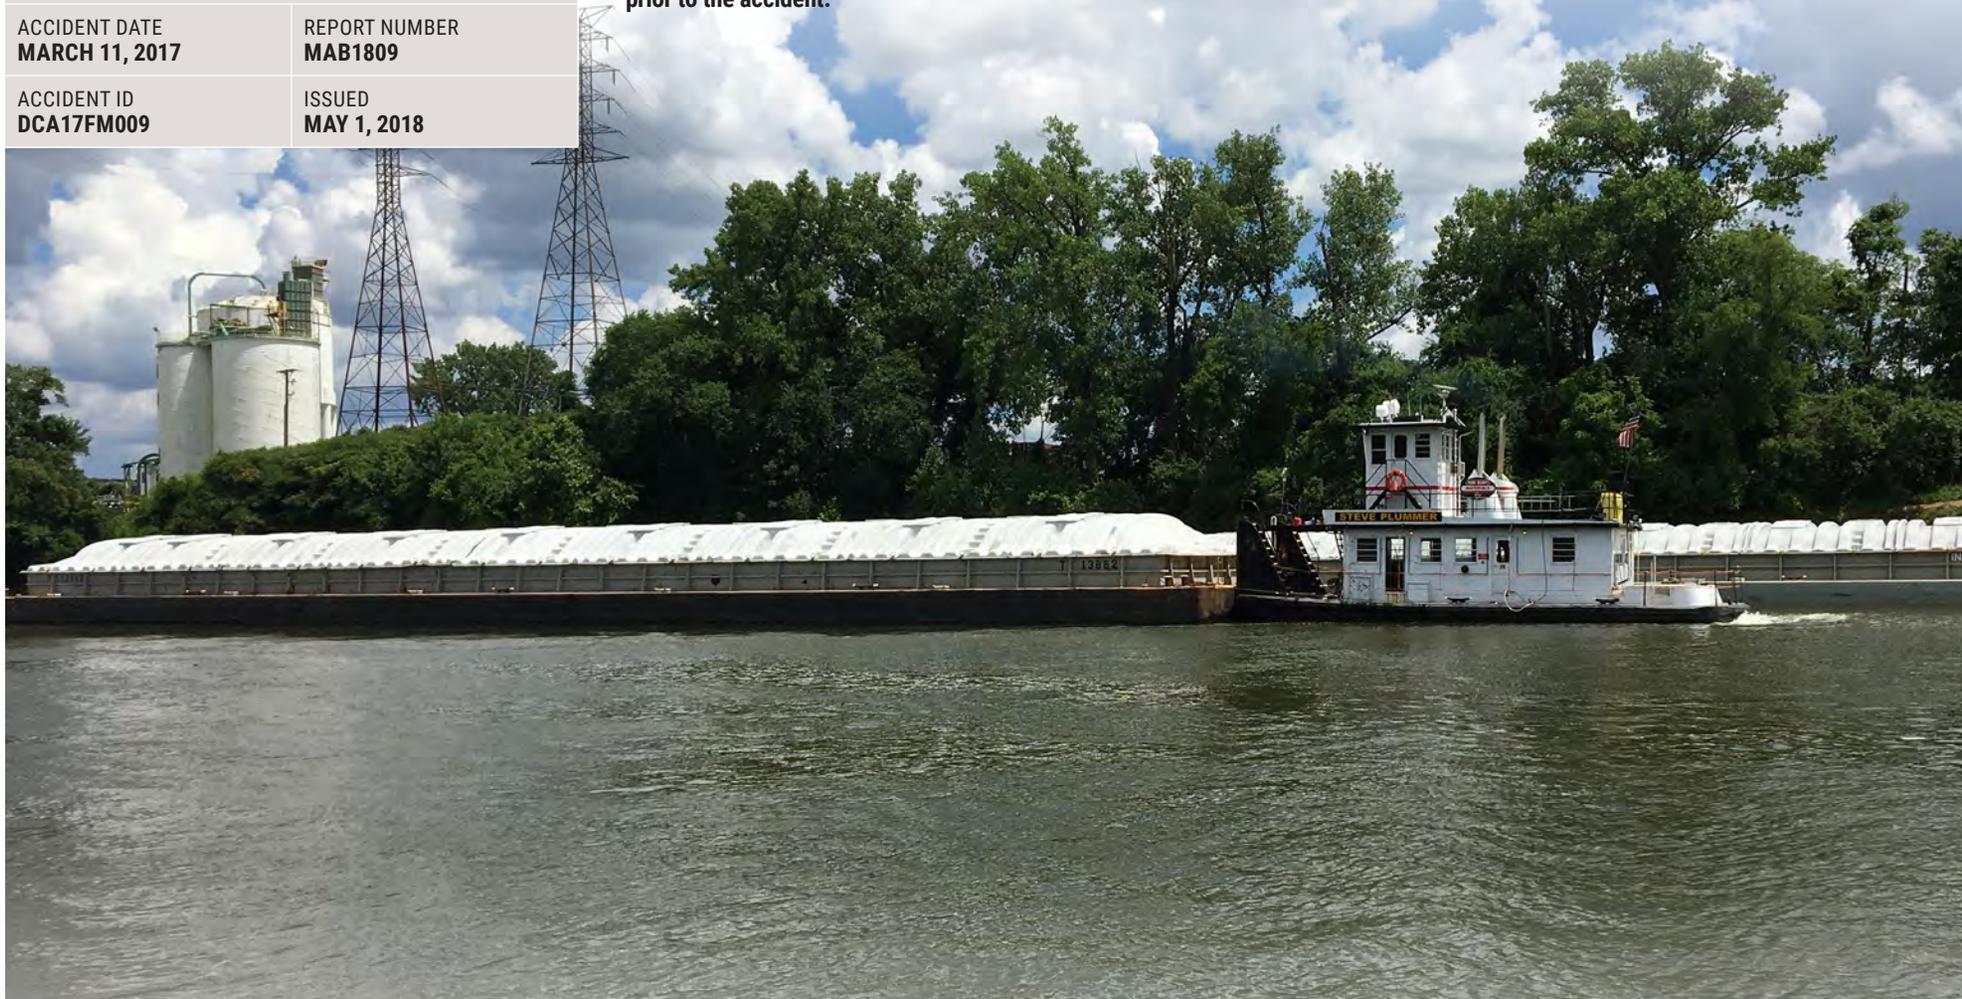
At 1110, the *Steve Plummer* tow approached the CSX Railroad Bridge at mile 190.4. The swing span was centered on a pivot pier, and vessels could transit on either side with 116 feet of horizontal clearance. The bridge also had two guard piers to protect the swing span when in open position: one guard pier was located 134 feet upstream of the pivot pier; the other, 134 feet downstream of it. Each guard pier was 28 feet wide and constructed with concrete and stone blocks.

As the *Steve Plummer* tow approached the bridge, the pilot positioned the tow to transit through the opening near the right descending bank; however, he noticed that the tow was being set toward the middle of the river. He then tried to correct for the set by increasing the vessel's speed and adjusting the rudders. The lead barge in the string successfully passed beneath the bridge span and then the upstream guard pier. However, at 1120, the second barge allided with the guard pier and caused pieces of stone to break off and fall onto the barge deck and into the river. The pilot sounded the general alarm, reversed the throttles, and shifted the rudders to prevent the third barge from hitting the guard pier and to keep the forward barges from wrapping around it, but to no avail. The third barge's stern struck the upstream guard pier, causing it to collapse into the river. The wire lines connecting the barges parted, and the barges drifted with the current, becoming pinned against the bridge.

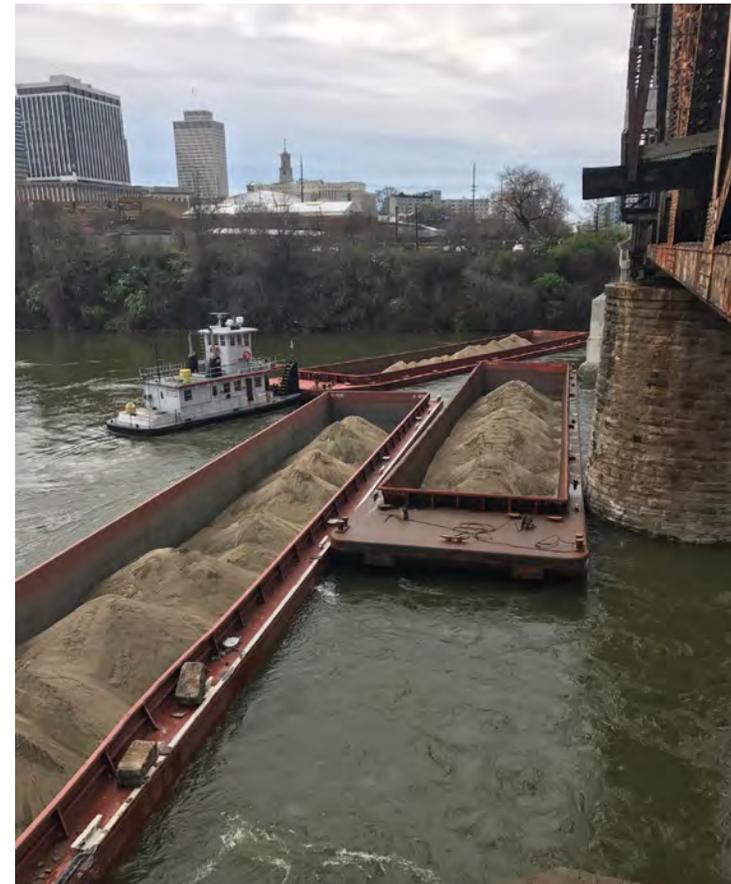
Figure 28. Barges from the *Steve Plummer* tow pinned against the upstream side of the CSX Railroad Bridge.

The NTSB determined that the probable cause of the *Steve Plummer* tow's allision with the CSX Railroad Bridge was the pilot's decision to tow three loaded barges during rising river conditions with swift currents, which overwhelmed his ability to maneuver the tow through the bridge.

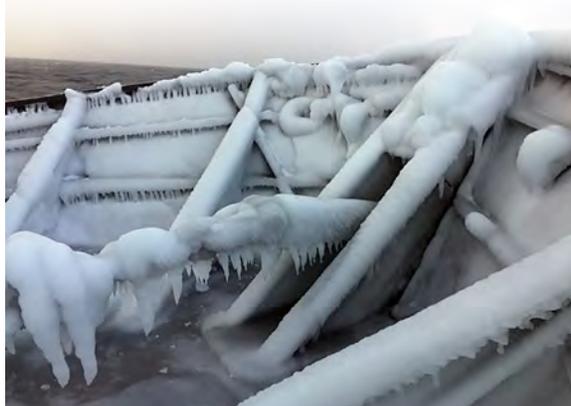
Figure 31. Ice coverage of the fishing vessel *Polar Sea*, which was transiting near the accident site.

Due to prolonged icing conditions, the *Destination* likely capsized in the relatively larger seas and stronger winds as it left the lee of St. George Island. The vessel sailed with 200 crab traps, which provided both interior and exterior surface area for ice to accumulate in the freezing spray. An analysis by the Coast Guard Marine Safety Center revealed that added weight high on the vessel from icing left it with a lower freeboard and decreased righting arm (lower stability) and ultimately vulnerable in the severe conditions.

1. During winter months, consult the National Weather Service's freezing spray forecasts and plan tactics and loading operations accordingly to decrease the risks of hazardous conditions.
2. Should your vessel be exposed to freezing spray conditions, consider the following precautions:
 - a. Decrease the number of gear on board or other gear above the main deck to reduce the available surface area for accumulating ice. These measures also serve to lower the vessel's center of gravity, thereby increasing its stability margin prior to encountering icing conditions.

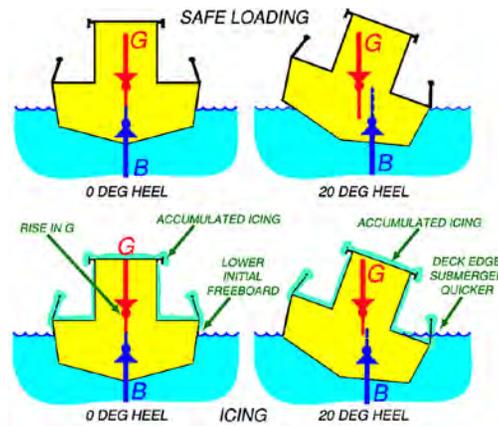
Figure 32. A diagram from the Coast Guard's guide on vessel stability illustrates the negative effect of icing.

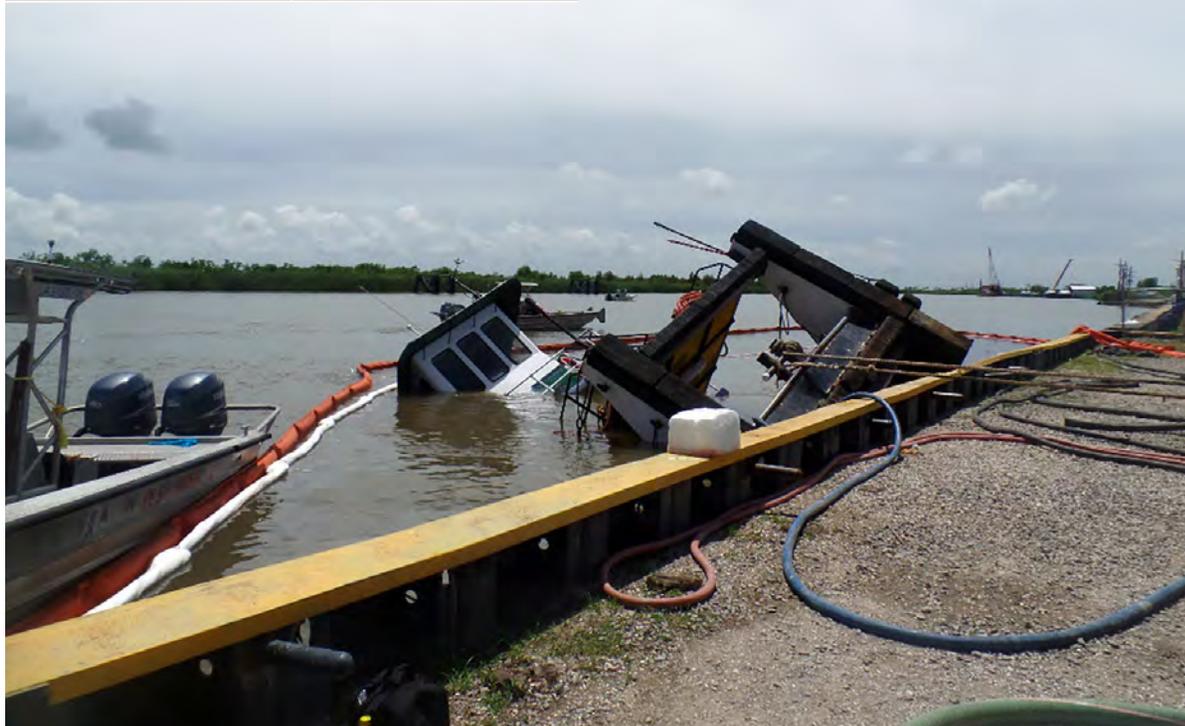
Figure 34. *Gracie Claire* awaiting salvage.

Following the accident, a 1-inch diameter hole was found in the bottom of the rudder compartment. The hole was likely present before fuel was loaded onto the towboat, and thus the compartment was likely flooded to near full. The lost buoyancy from the water in the compartment would have resulted in the towboat having less freeboard.

The NTSB determined that the probable cause of the capsizing and sinking of the *Gracie Claire* was the towing vessel's decreased stability and freeboard due to undetected flooding through a hull leak in the rudder compartment, which made the vessel susceptible to the adverse effects of boarding water from the wake of a passing vessel.

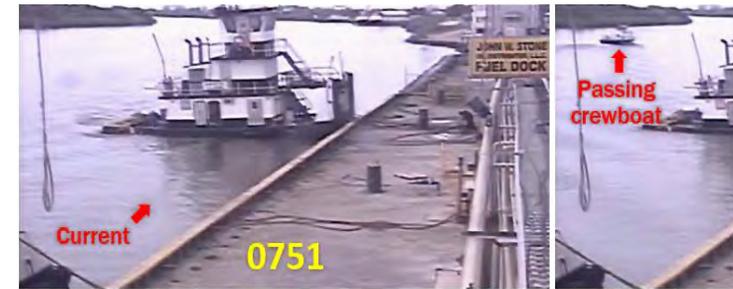
Figure 35. Screenshots of the *Gracie Claire*, from video captured by the southwest view of the dock's camera, starting a minute after loading began and continuing through the sinking.

At 0755, video footage showed a crewboat passing astern of the *Gracie Claire*, and its wake washed onto the starboard side of the towboat's stern. The towboat then slowly rolled to starboard, and water eventually began flowing over the sill of the open engine room door on the starboard side. The *Gracie Claire* continued to roll until it was almost completely submerged at 0802. The mooring lines held the bow above the water's surface.

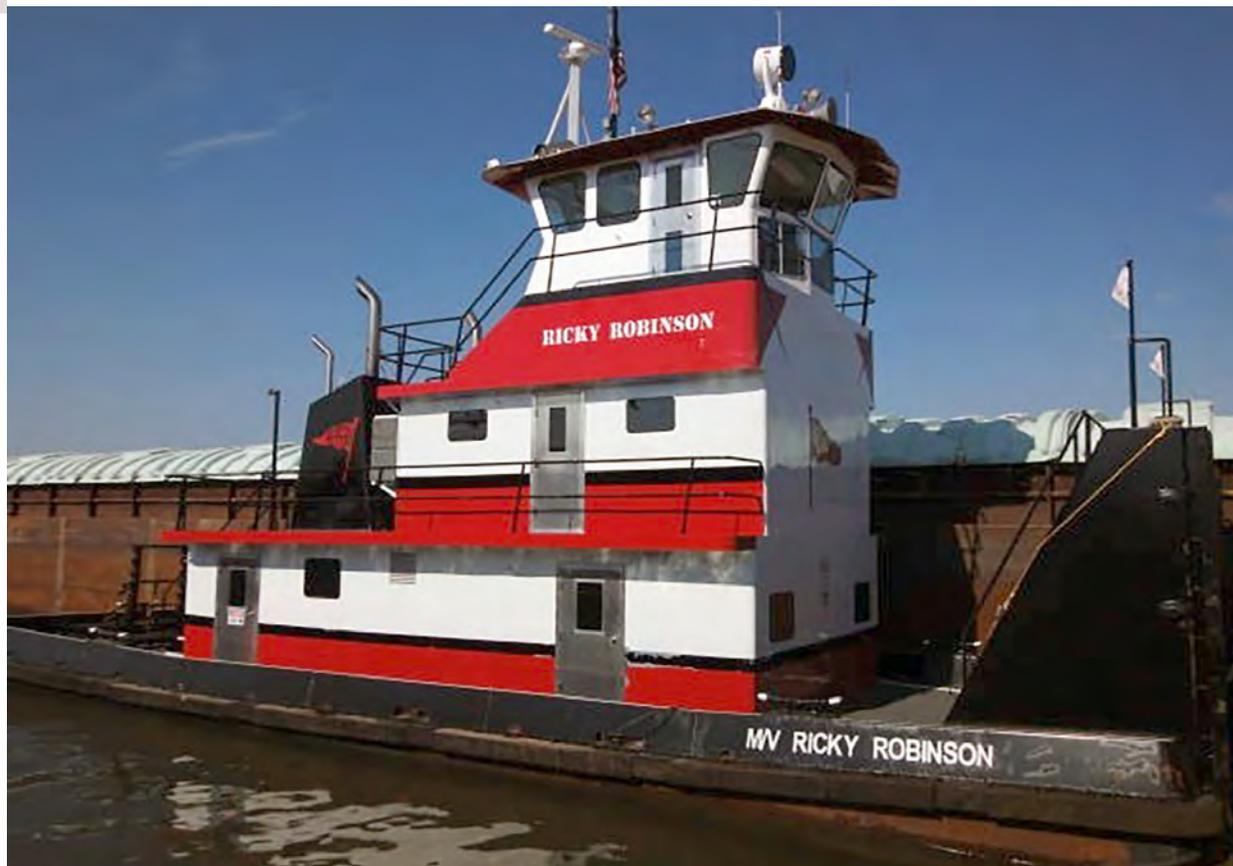
Figure 41. *Ricky Robinson* post-salvage. Two inset photos show (at left) both aft voids missing hatch covers, with a yellow square highlighting where the submersible pump was found, and (at right) the open starboard engine room door that was tied off to the stairs.

When the vessel was salvaged about a week after the accident, only the starboard-side door was found open; it had been tied back with a rope to the stairs. The port- and starboard-side hatches for the aftermost and forward stern voids were also found open, and all were missing their covers (four covers total).

The NTSB determined that the probable cause of the sinking of the towing vessel *Ricky Robinson* was the pilot's decision to proceed with unsecured deck hatches at a speed that resulted in water on deck and flooding of the aft voids. Contributing to the sinking was the company's inadequate oversight to ensure that crews kept hatches closed while the vessel was under way and that ongoing watertight issues with the voids were addressed.

Maintenance issues and other conditions affecting the safe operation of a vessel should be promptly reported to the operating company. Reporting systems should provide specific guidance regarding critical equipment, hull integrity, and operational safety. A robust reporting system should also include procedures for company oversight to ensure that crews are reporting issues and that the operating company is tracking and promptly addressing them.

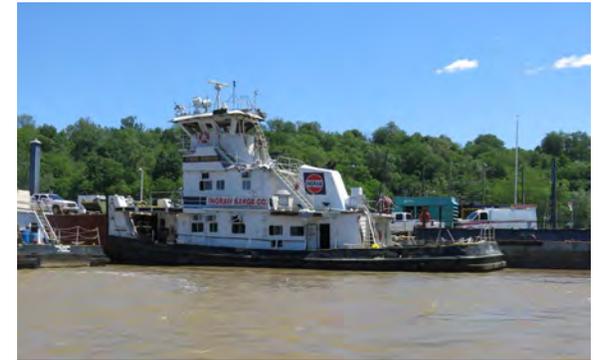
Figure 44. *Todd Brown* refloated after salvage.

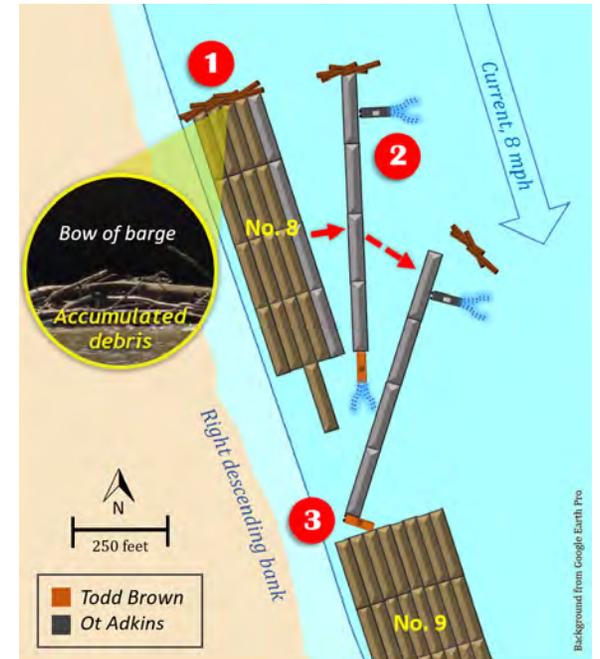
The NTSB determined that the probable cause of the collision and sinking of the uninspected towing vessel *Todd Brown* was the pilot’s underestimation of the effect of the river current on the barge string being maneuvered during a de-drifting operation.

1. Original configuration of barges.
2. Intended maneuver with string of barges to allow river current to flush debris from lead barge.*
3. Position of *Todd Brown* after the current overpowered the towing vessels.*

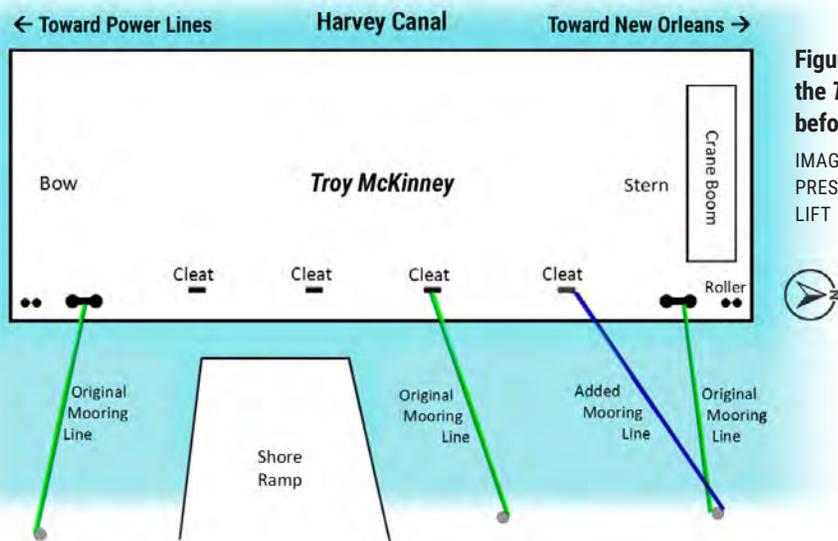
Forward and aft movement of a moored vessel is best prevented by forward- and aft-leading lines. Investigators believe that the *Troy McKinney*'s mooring lines were led from vessel to shore at an angle insufficient to prevent the barge from moving forward as the *Gail Cecilia* tow passed.

Figure 46. Mooring line arrangement for the *Troy McKinney* on June 1 (six days before the accident).

The NTSB determined that the probable cause of crane barge *Troy McKinney* striking and damaging overhead power lines was its insufficient mooring arrangement, which did not prevent the barge from excessive movement and breaking away.

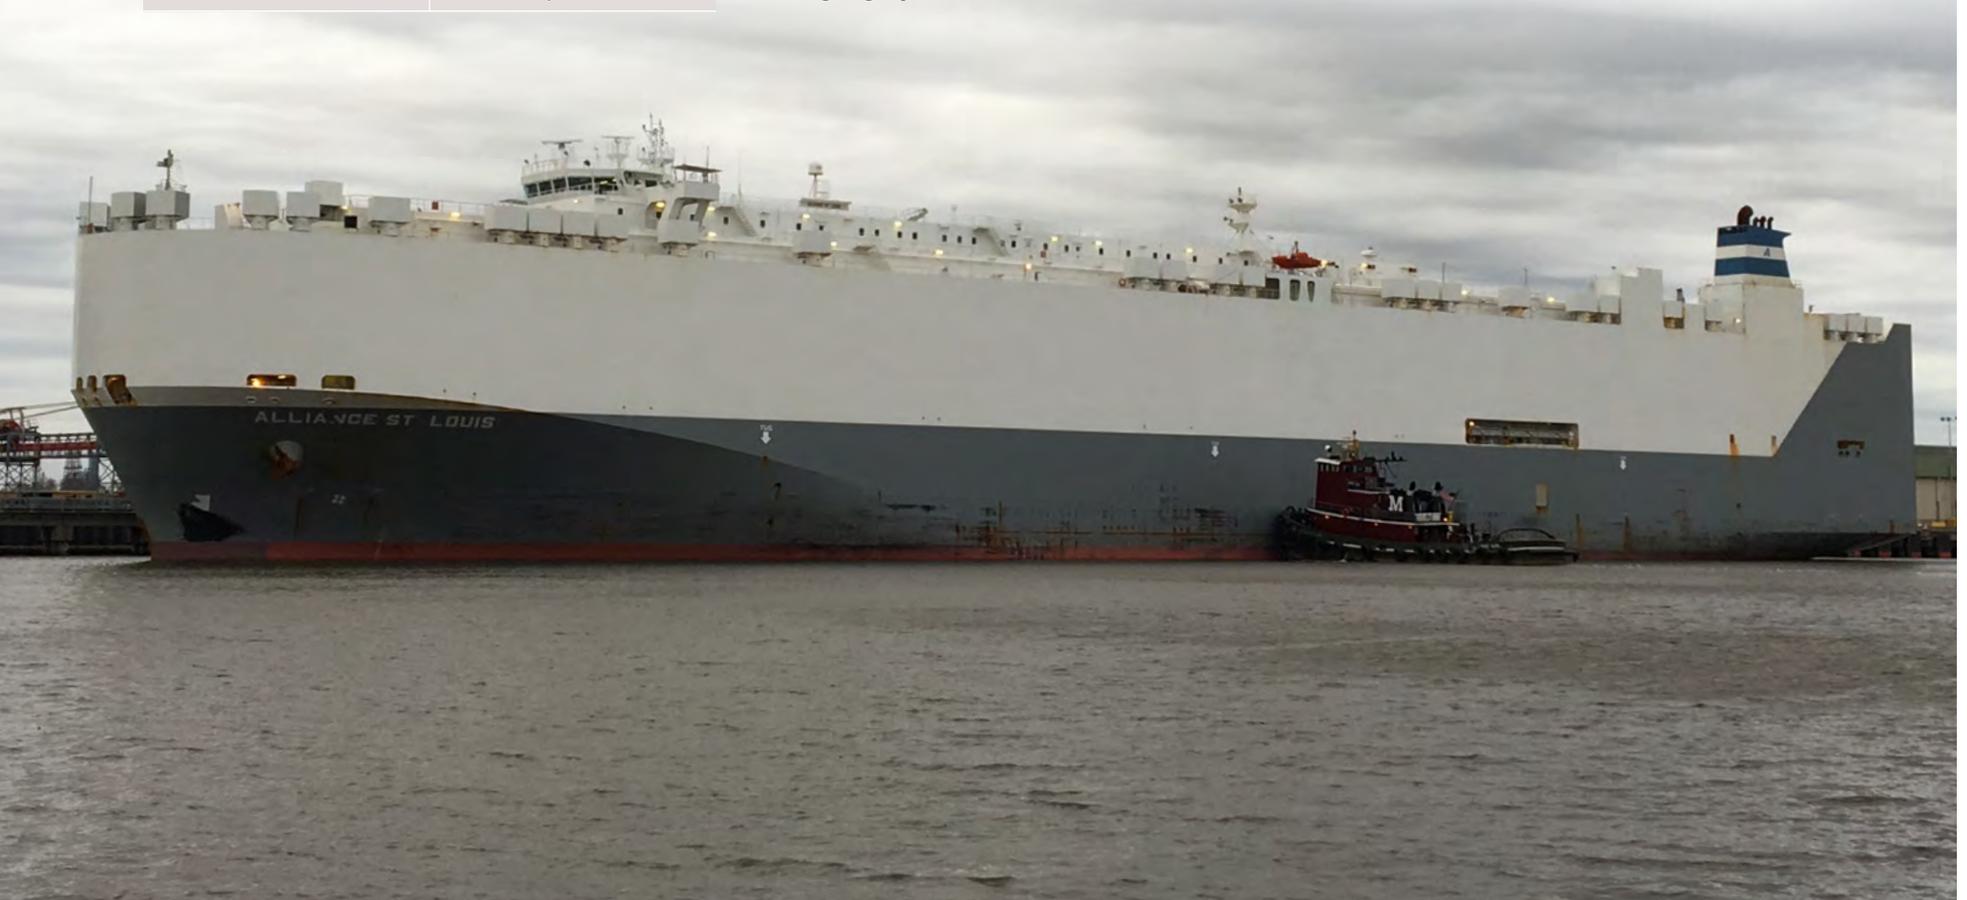
Figure 48. *Alliance St. Louis* pierside in Port Arthur, Texas, undergoing repair after the fire.

The NTSB determined that the probable cause of the engine room fire aboard the *Alliance St. Louis* was improper tightening of a pipe plug on the top cover of the no. 6 cylinder fuel pump housing, which resulted in a high-pressure release of marine gas oil. Contributing to the fire was the improper attachment of a fuel spray shield to the top cover, which allowed fuel to spray directly onto the cylinder's hot exhaust pipe and ignite.

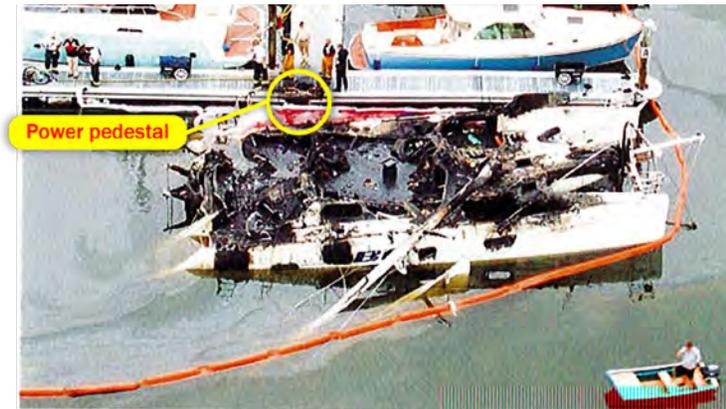
Figure 55. *Best Revenge 5* partially submerged at dock postaccident. PHOTO BY COAST GUARD

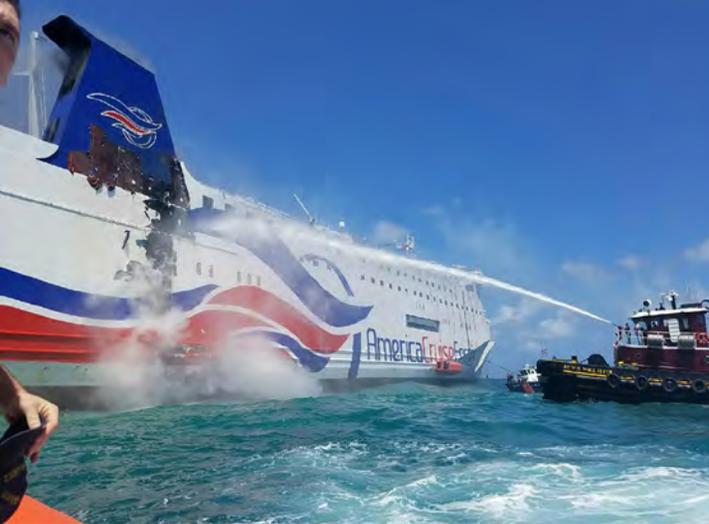
Figure 57. A harbor tug cooling the starboard side of the Caribbean Fantasy. PHOTO BY COAST GUARD

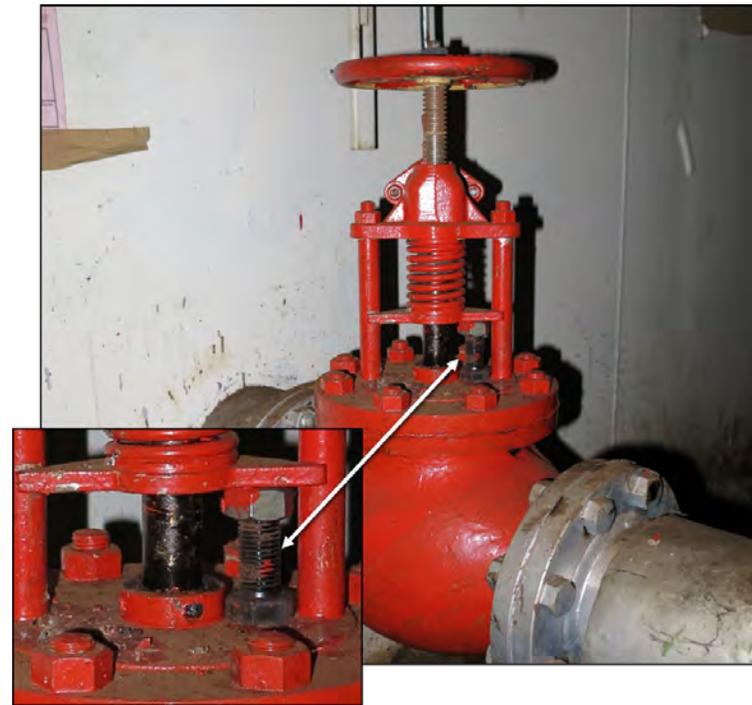
Figure 58. Postaccident photo of Caribbean Fantasy's quick-closing valve for the starboard heavy fuel oil storage tank that was blocked open with a bolt and nut.

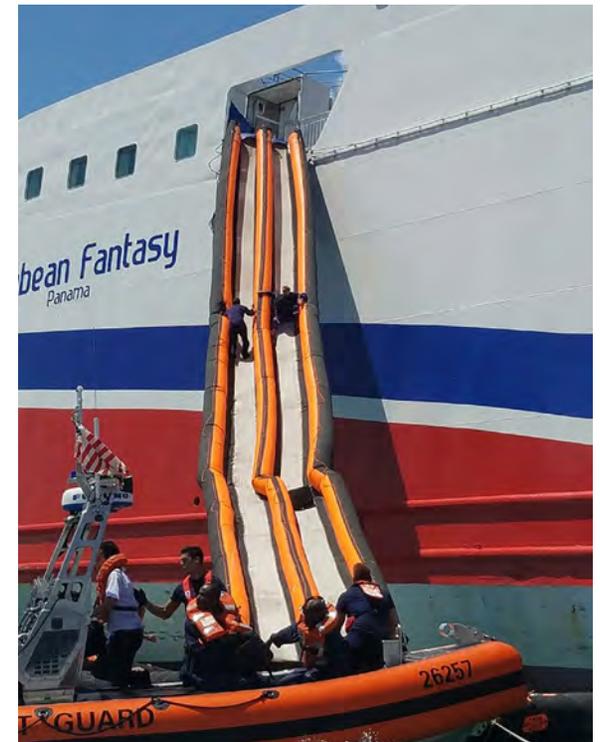
Figure 60. *Caribbean Fantasy's* marine evacuation system deployed on the starboard side. PHOTO BY COAST GUARD

Passengers were then directed to the starboard MES; however, the starboard MES was also not deployed as designed. The slide was kinked in the middle of the chute, with an extreme angle at the top of the slide and a flat angle at the bottom. Several passengers who used the slide suffered injuries due to the kink in the slide. A Coast Guard vessel eventually rigged a line to the floating platform of the MES to pull the slide out straighter and prevent further injuries. The NTSB determined that the failure to deploy the port and starboard MESs was the result of inadequate training of the crew.

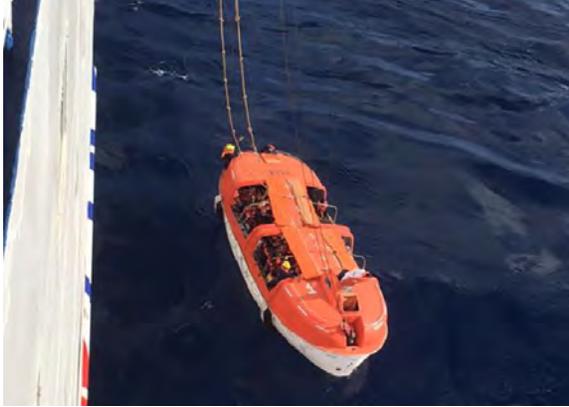
Juan and disembarked its passengers. Lifeboat no. 1 began taking on water and its engine failed to start, so passengers were transferred to Good Samaritan vessels. The crew on lifeboat no. 3 was never able to detach the release hooks, and the vessel was raised out of the water to prevent waves from smashing it against the side of the ship. As it was being raised, the winch motor on the davit failed due to overload (it was not designed to lift a fully loaded boat), leaving the boat hanging 6 feet above the water. Passengers were eventually transferred one-by-one to a Coast Guard aids-to-navigation boat.

Figure 61. Lifeboat no. 1 in the water and unable to open the release hooks, about 0825. PHOTO BY A CARIBBEAN FANTASY PASSENGER

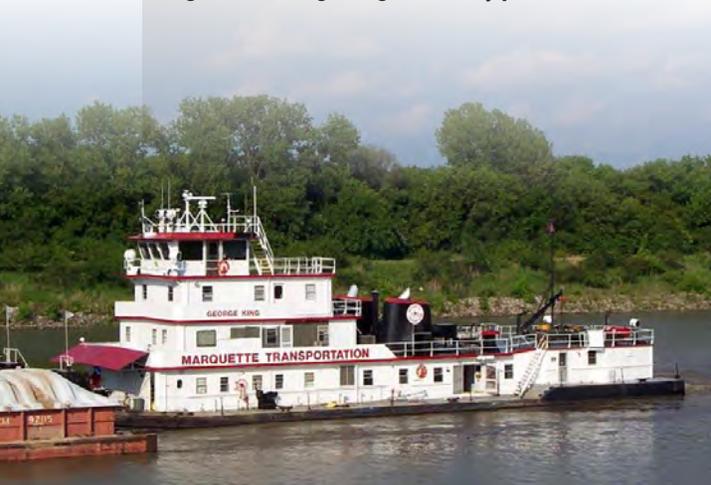
Figure 64. *George King* still burning on the day after the fire started. PHOTO BY COAST GUARD
