SAFER SEAS

DIGEST 2018

LESSONS LEARNED
FROM
MARINE ACCIDENT
INVESTIGATIONS

National
Transportation
Safety Board

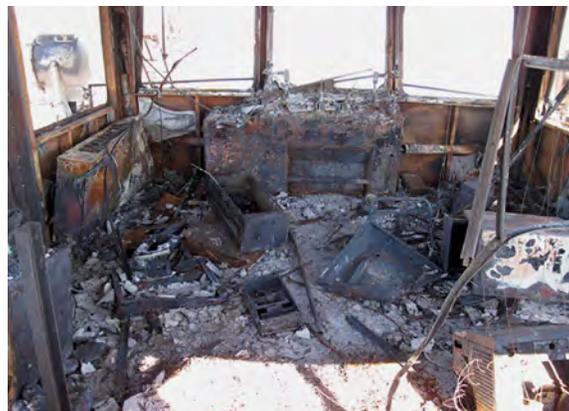
Figure 66. Charred remains of the wheelhouse.

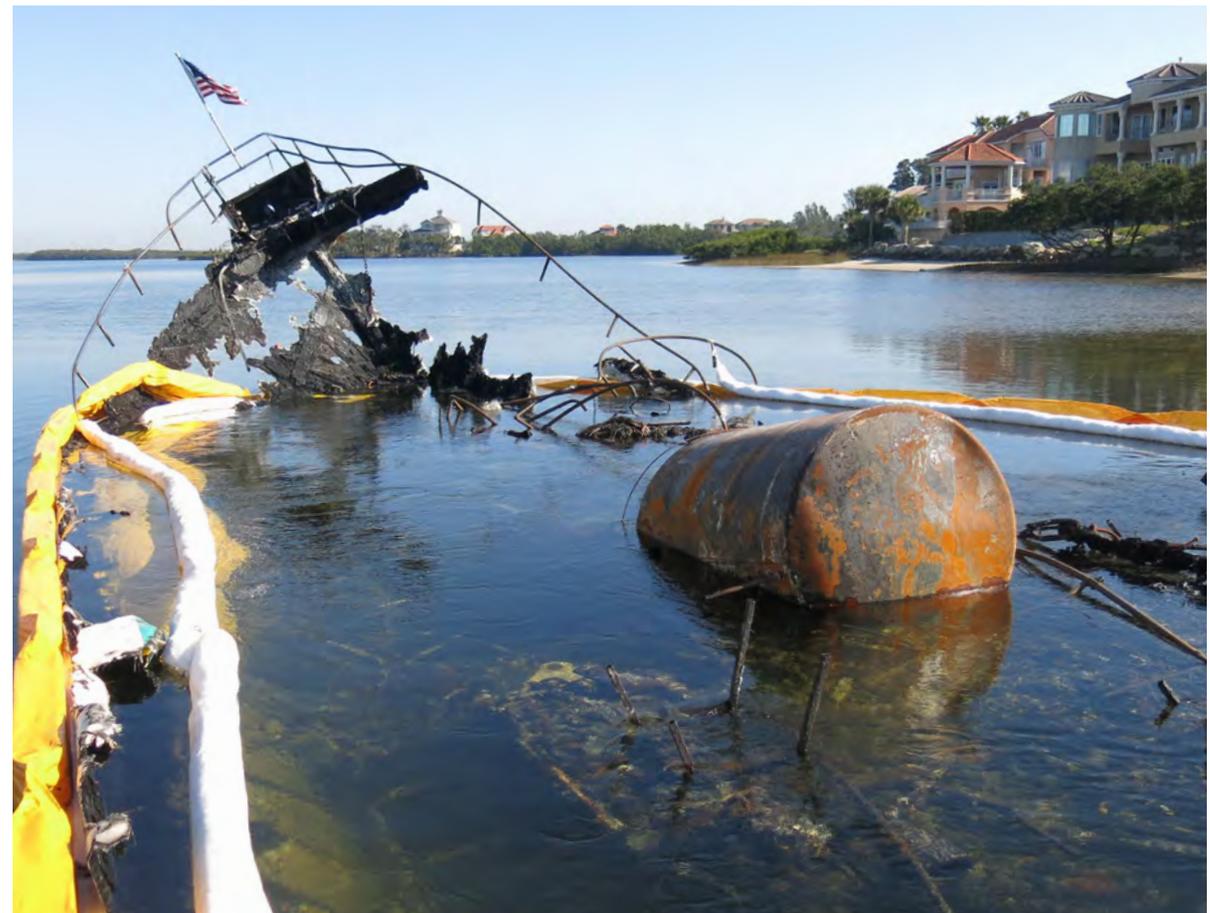
Figure 76. Sunken remains of the *Island Lady*.

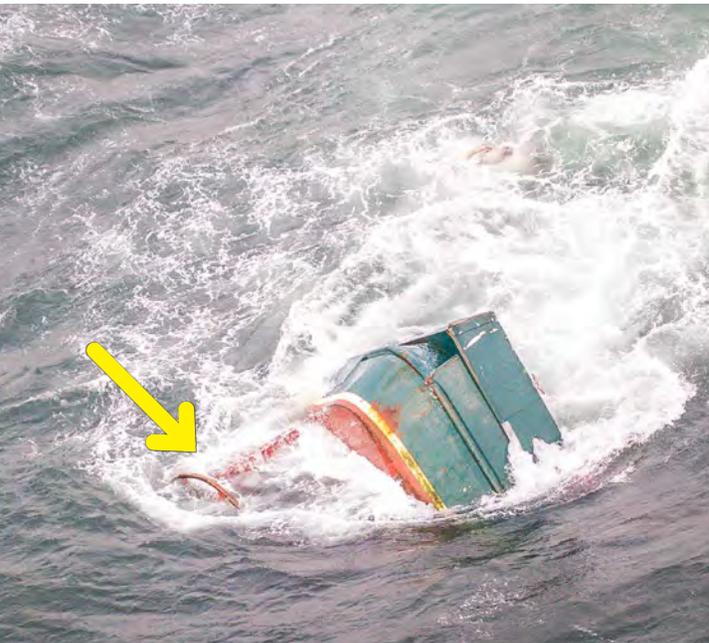
Figure 81. Starboard aft quarter of the *Ambition* prior to sinking. Arrow identifies part of the net guard installed to protect the propeller and rudder.

A postaccident overflight photograph showed struts and bars that were part of the propeller net guard modification. The vertical strut was fixed to the underwater portion of the hull plate beneath the lazarette at the transom. If the guard had contacted the ground, drifting debris (such as a log), or other objects, the weld points where the struts were attached to the hull may have been subject to cracking. Such cracking could have been the source of flooding during the accident voyage. Although the crew did not report a grounding or contact with an object, forces working on the guard over time may have also been transmitted and concentrated to the point of attachment to the hull.

The NTSB determined that the probable cause of the sinking of the fishing vessel *Ambition* was the flooding of the lazarette from a breach in the steel hull.

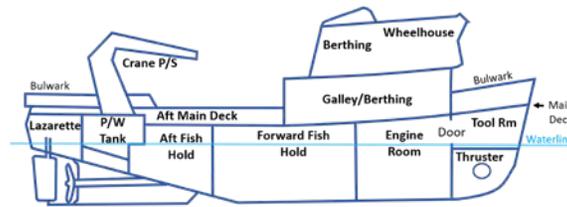
Figure 82. Simplified profile of *Ambition*.

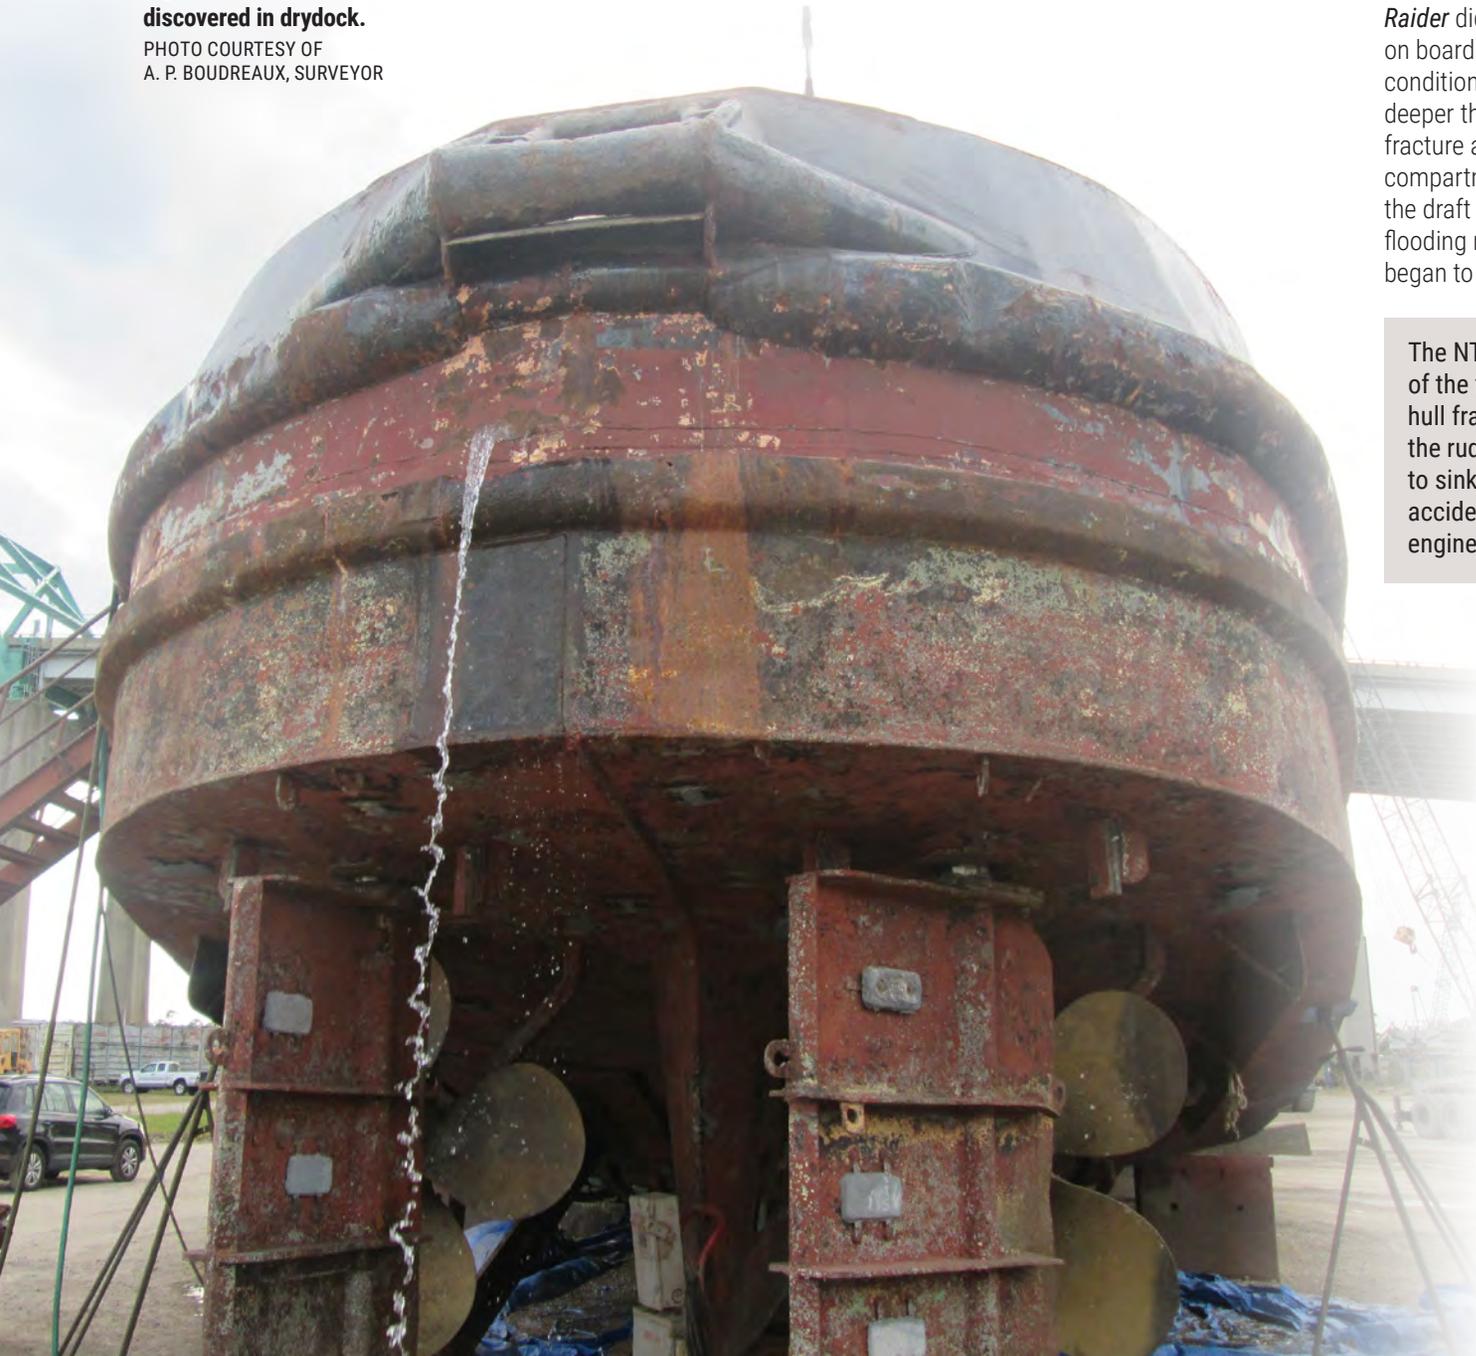
On November 30, the *Atlantic Raider* was put into drydock. A horizontal hull fracture 9.5 inches long and 0.5 inches wide was found on the vessel's stern at a weld seam, about 10.5 feet above the keel. The vessel's rudder compartment was on the inboard side of the stern hull fracture. A 1-inch hole and two pinholes were also discovered on the corroded bulkhead leading into fuel tank no. 4. The captain and the owner's representative stated that they did not know of the fracture until after the accident.

Figure 84. Stern hull fracture discovered in drydock.

According to a company representative, the *Atlantic Raider* did not normally have 26,000 gallons of fuel on board as it did the morning of the accident. At that condition, the draft of the vessel would have been deeper than normal—about 10.5 feet—putting the hull fracture at the waterline. Water likely entered the rudder compartment through the hull fracture and increased the draft by the stern, which would have caused the flooding rate to increase. About 5 hours later, the vessel began to sink by the port quarter.

The NTSB determined that the probable cause of the flooding of the *Atlantic Raider* was a stern hull fracture that allowed ingress of water into the rudder compartment and caused the vessel to sink by the port quarter. Contributing to the accident was flooding through an open door to the engine room.

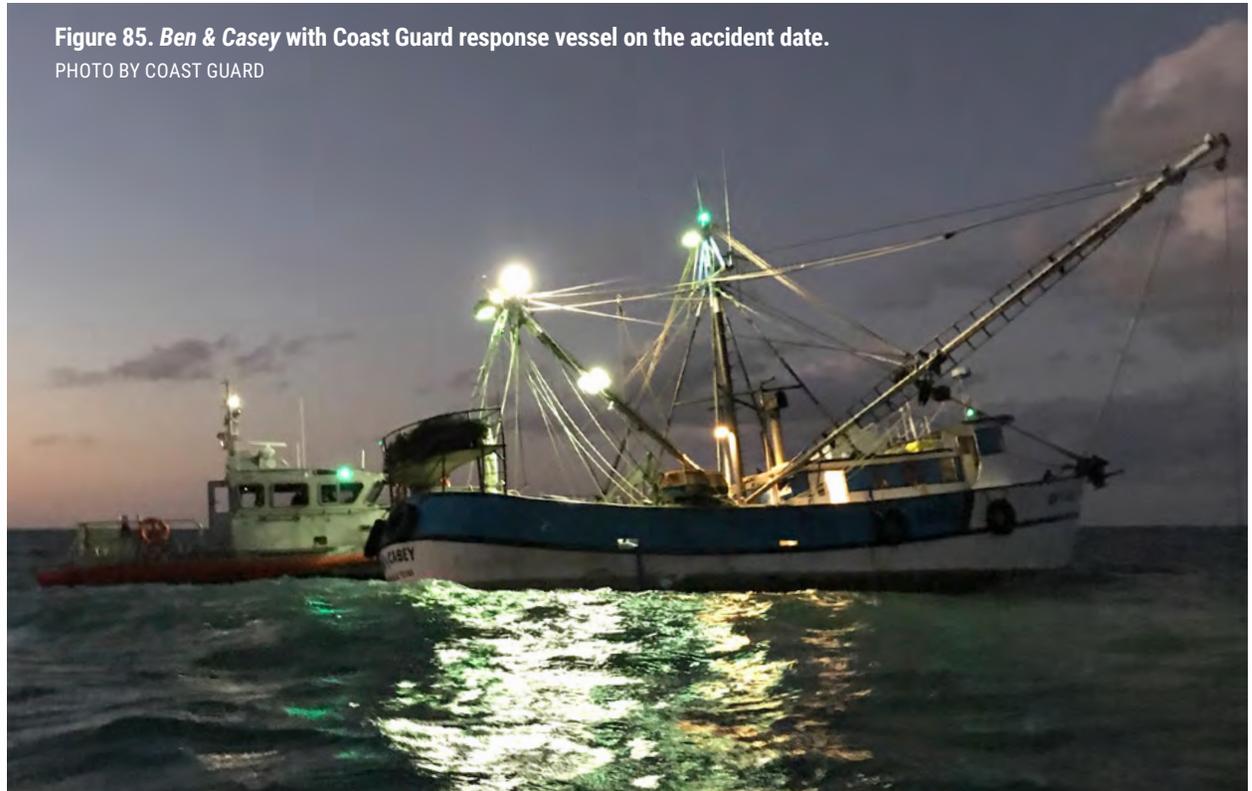
Figure 85. *Ben & Casey* with Coast Guard response vessel on the accident date.

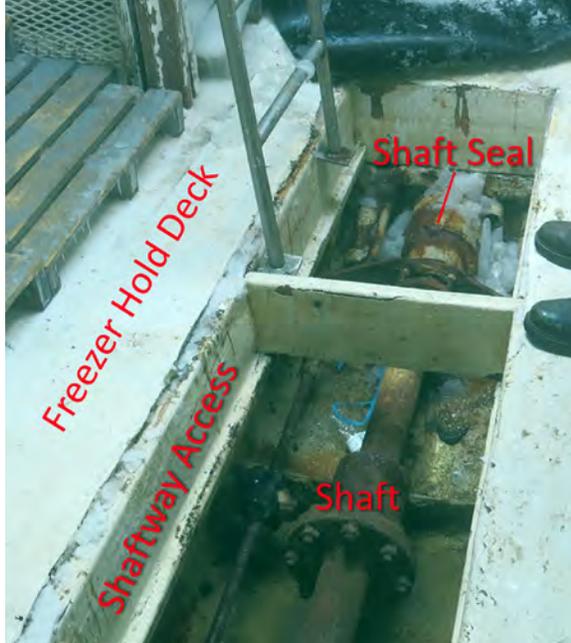
Figure 86. Shaftway of *Jake M*, a vessel with identical shafting to *Ben & Casey*, as viewed from the freezer hold while facing aft.

The loss of propulsion and the immediate increase in engine rpm reported by the captain just after the crew heard the loud noise suggested that the propeller shaft on the *Ben & Casey* sheared. Once the shaft completely sheared, it is likely that either the weight of the propeller caused the shaft to partially back out of the stern tube or that excessive movement of the shaft in the stern tube seal allowed water to enter the hull.

The NTSB determined that the probable cause of the flooding and sinking of the fishing vessel *Ben & Casey* was a sheared propeller shaft that allowed water ingress into the hull through the shaft seal.

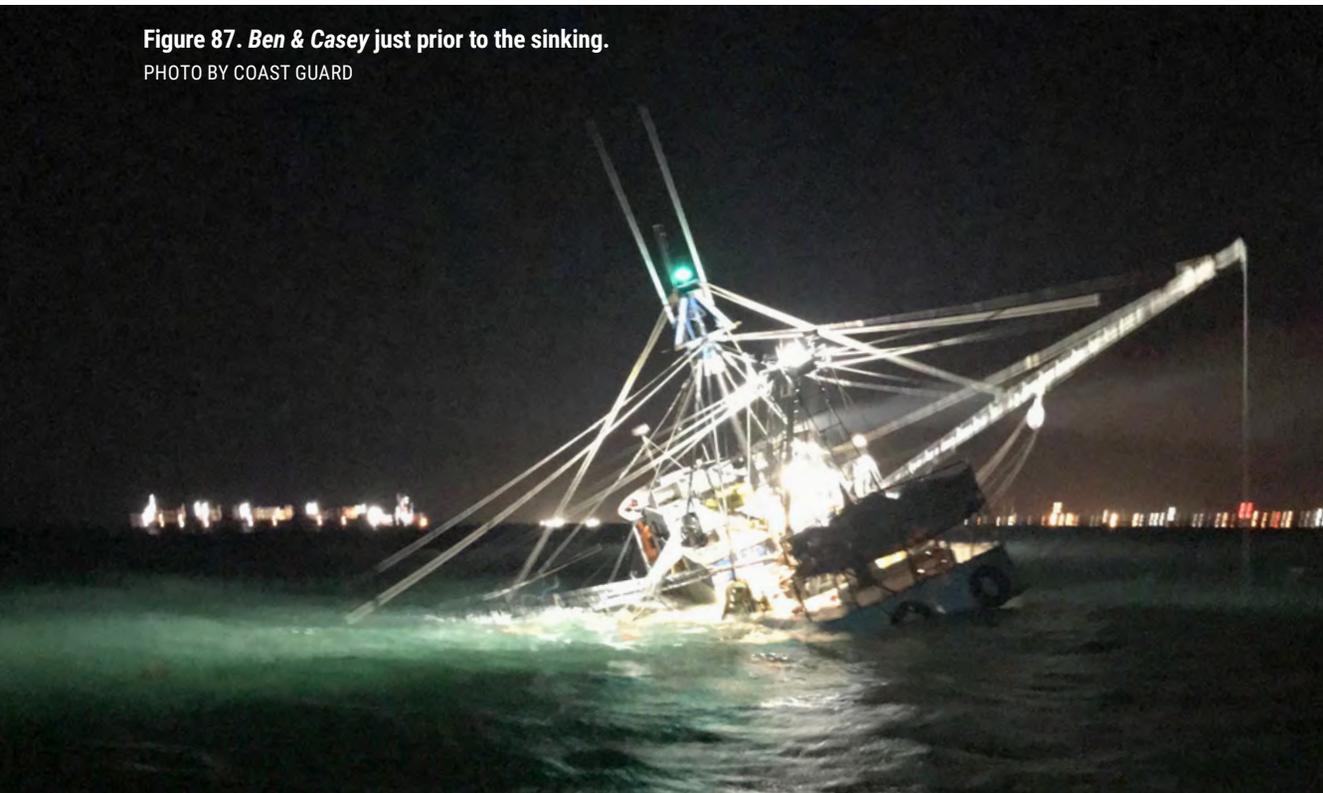
Figure 87. *Ben & Casey* just prior to the sinking.

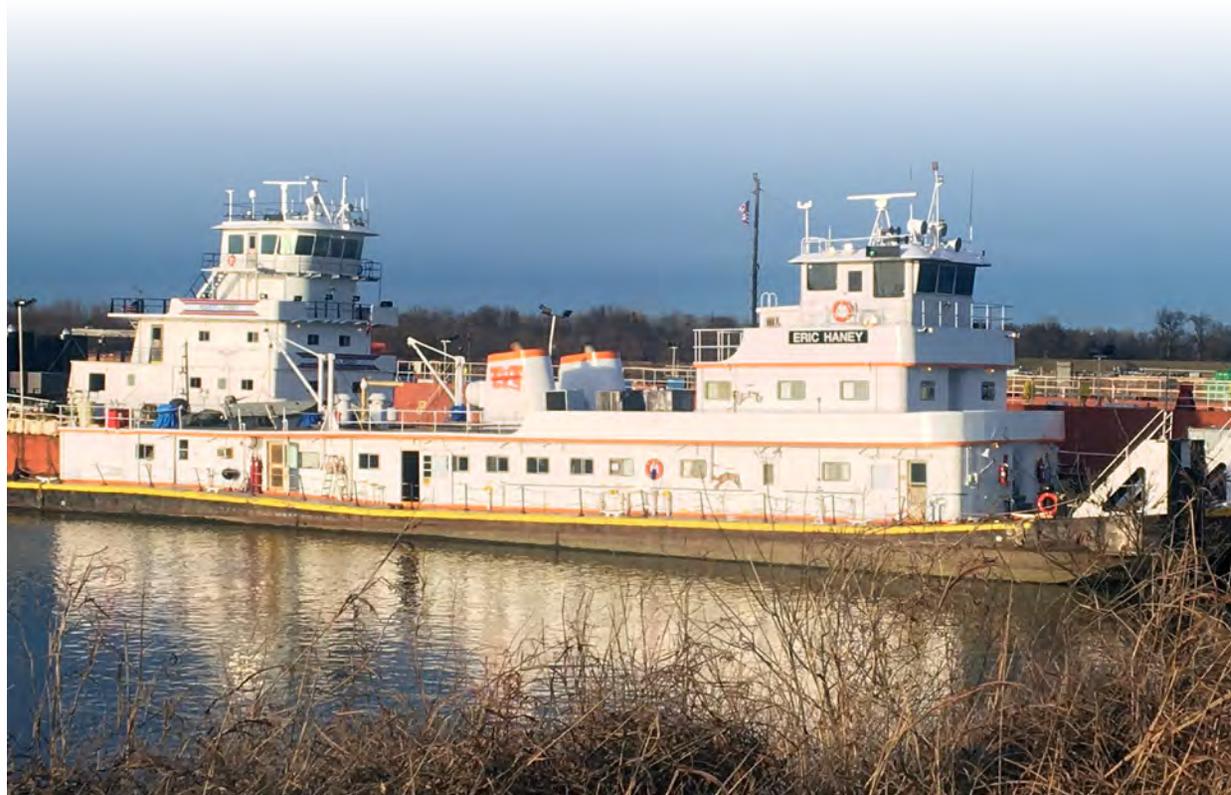
Figure 88. *Eric Haney* before the accident.

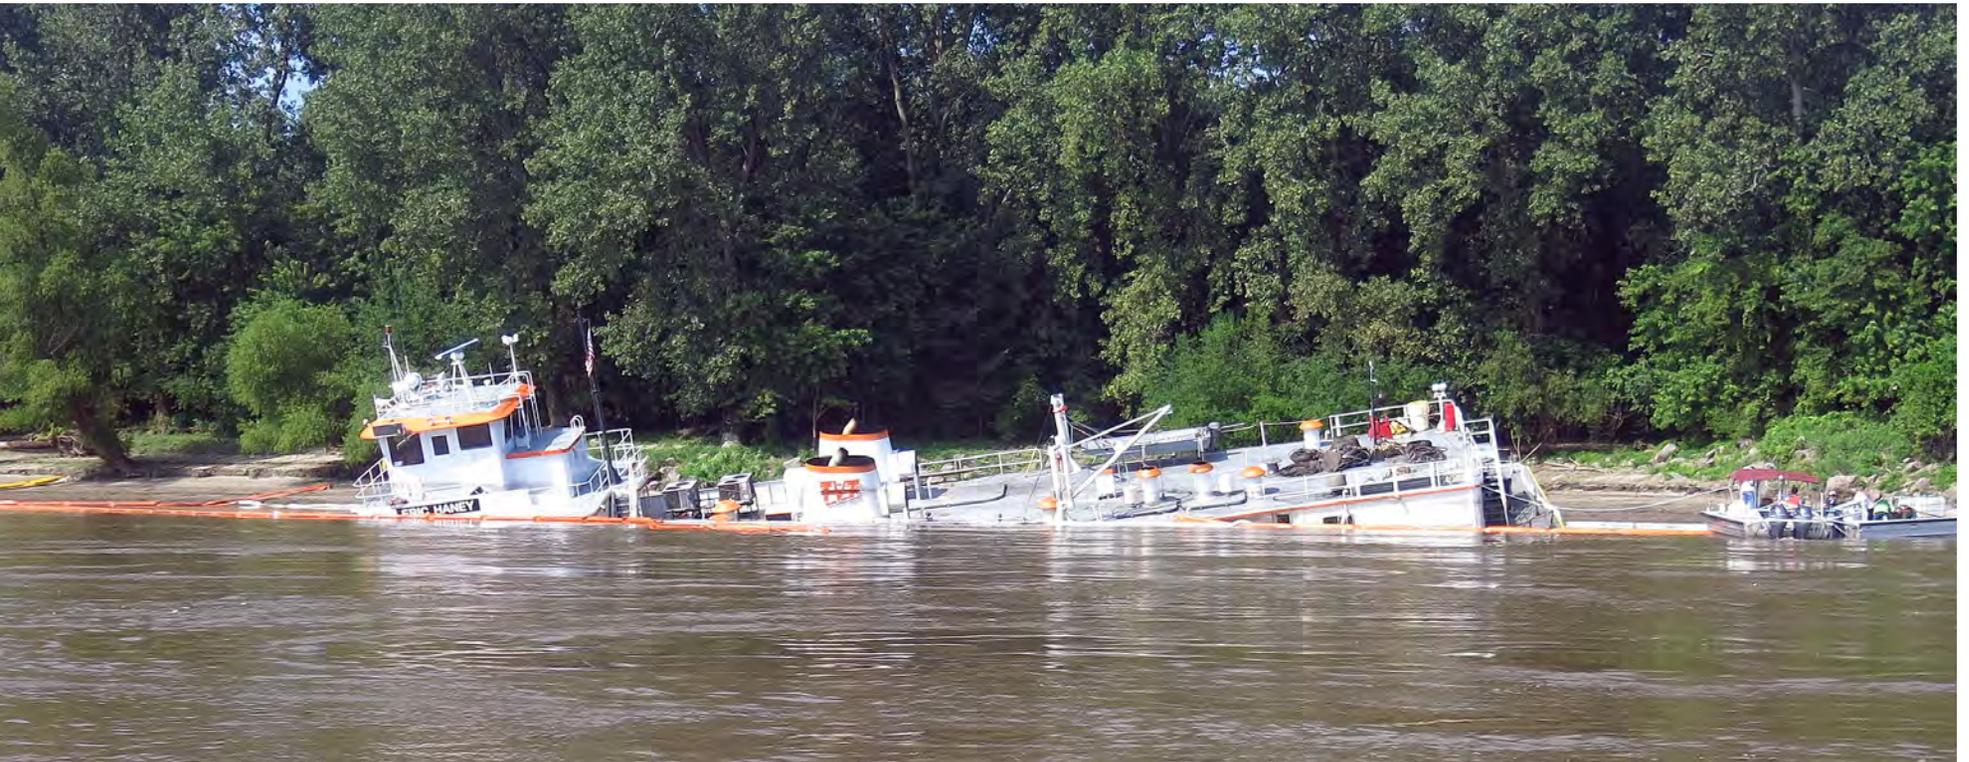
The NTSB determined that the probable cause of the grounding and subsequent sinking of the *Eric Haney* was the pilot’s failure to identify a charted navigation hazard (erosion-control dike) during towing operations.

Figure 89. *Eric Haney* after the sinking.

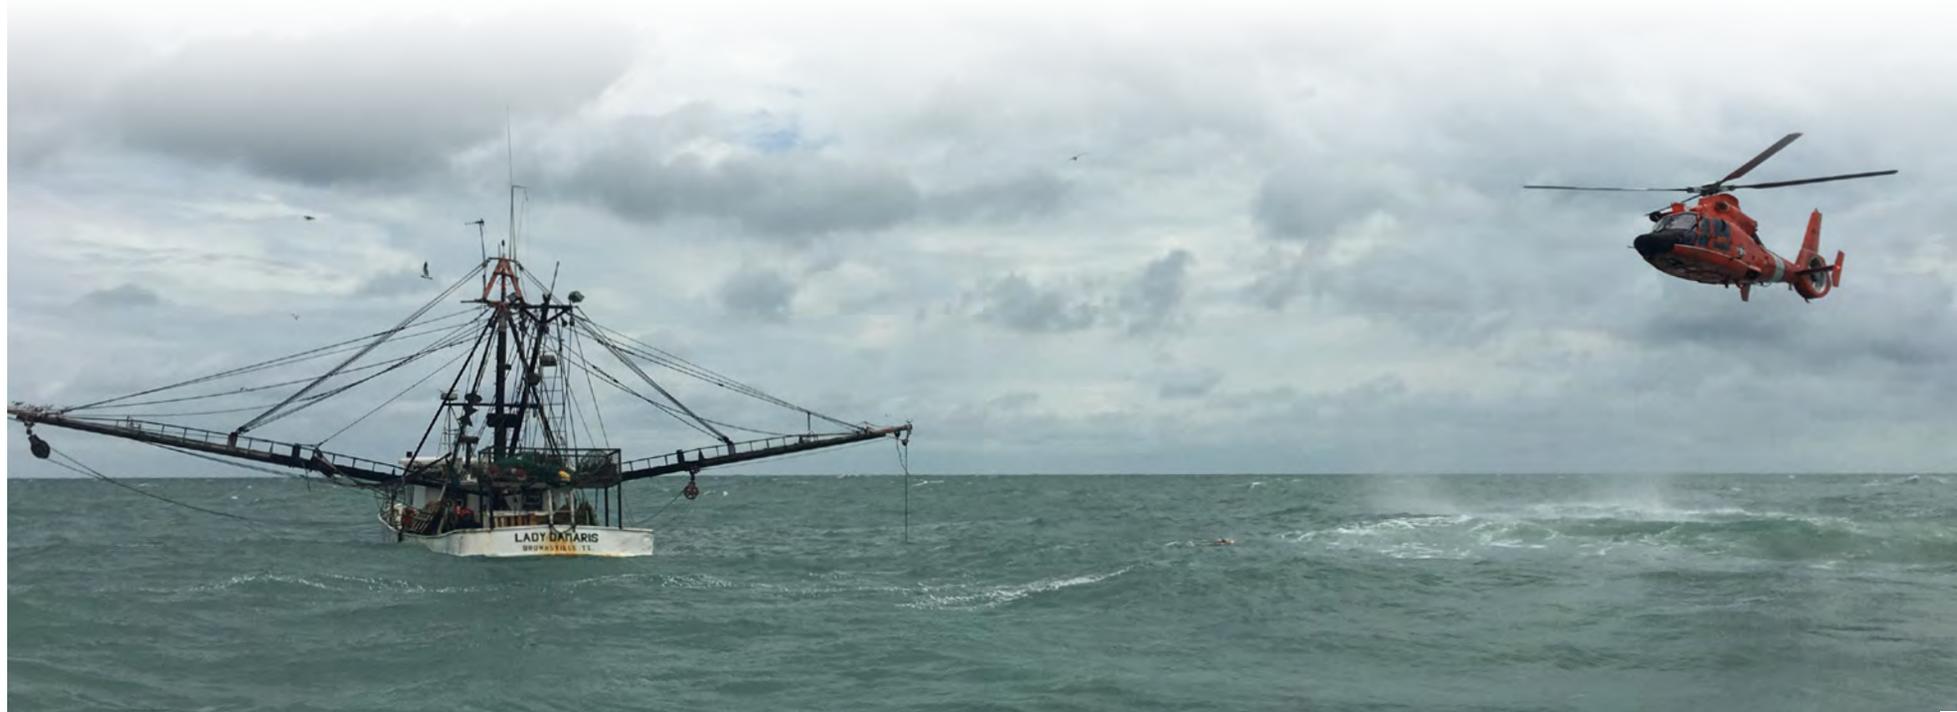
Figure 90. *Lady Damaris* and arriving Coast Guard helicopter carrying a rescue swimmer and portable pump.

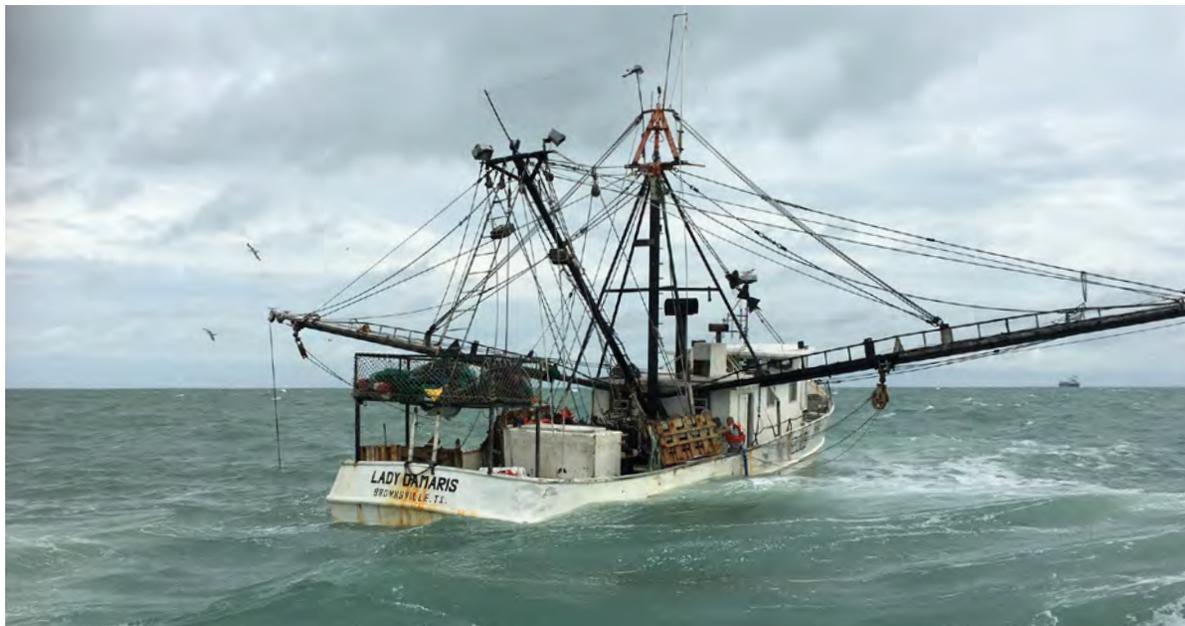
Figure 91. *Lady Damaris* about 1049 on the morning of the accident. PHOTO BY COAST GUARD

The NTSB determined that the probable cause of the flooding and sinking of the fishing vessel *Lady Damaris* was the captain's decision to continue to operate with a known hull leak.

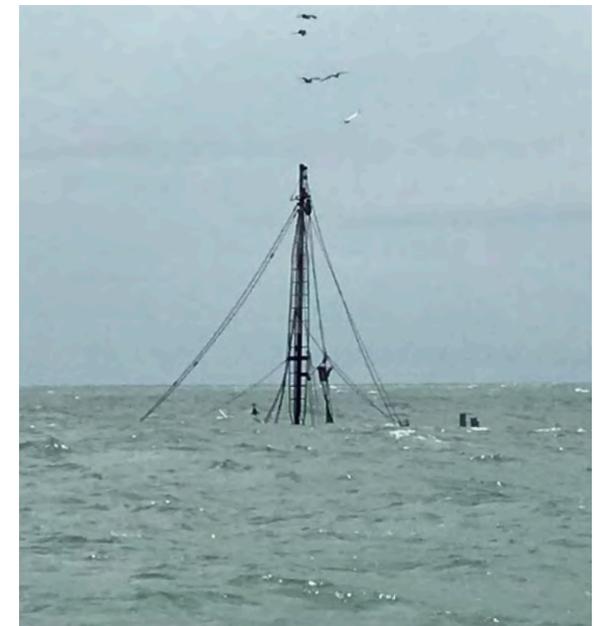
Figure 93. Portside outrigger of sunken *Lady Damaris* about 1206 on the day of the accident.

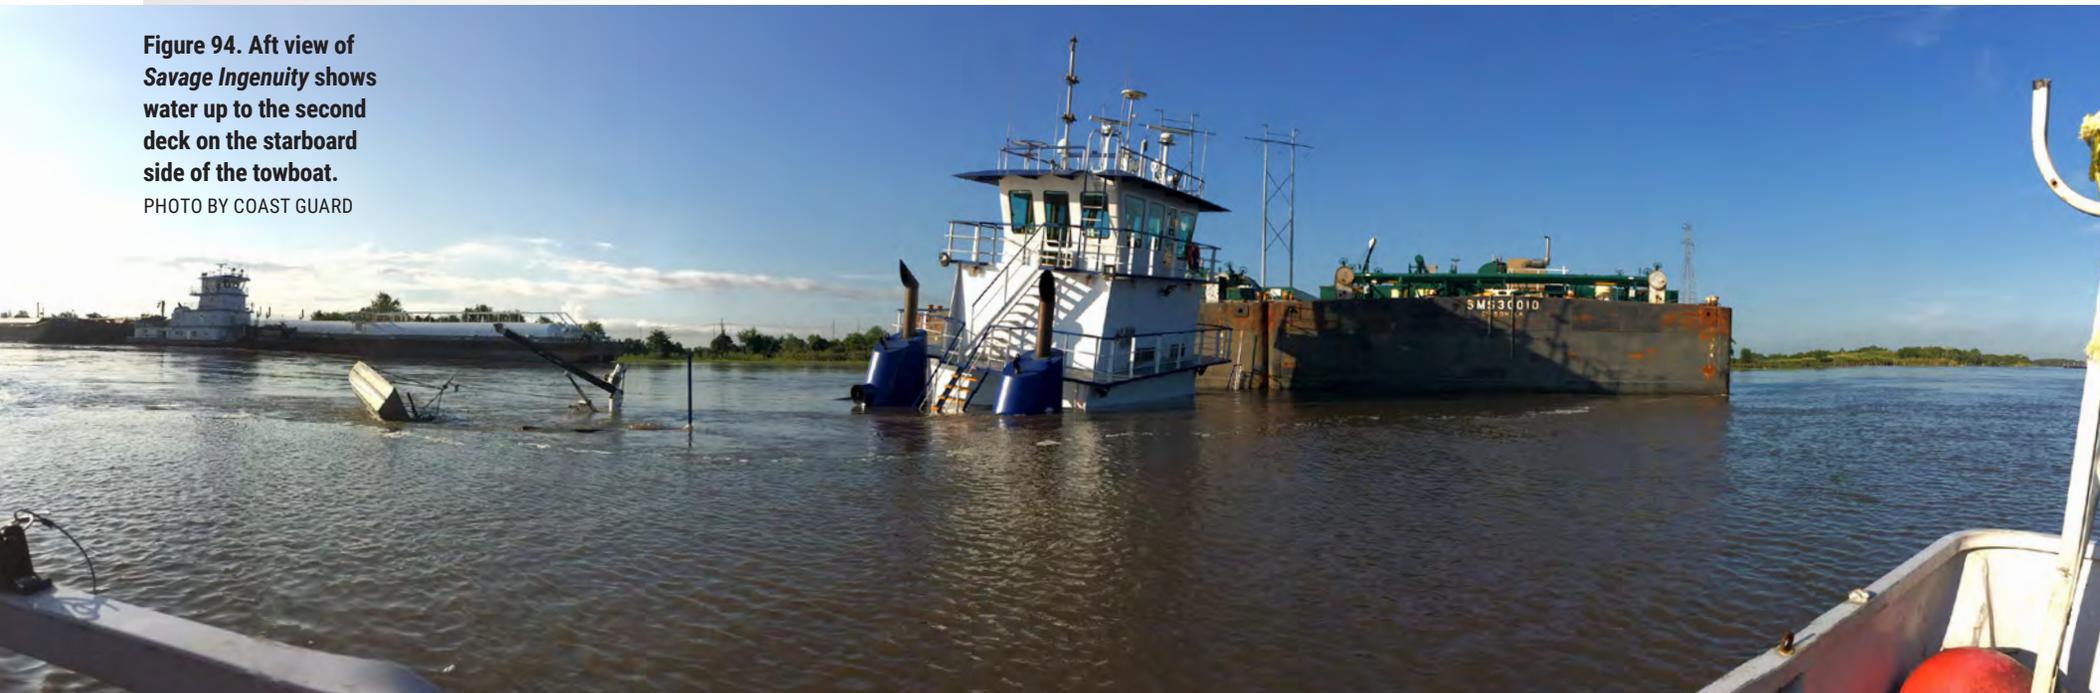
Figure 94. Aft view of *Savage Ingenuity* shows water up to the second deck on the starboard side of the towboat.

he observed water flooding into the engine room. The tow was being maneuvered about perpendicular to the strong eastbound current at the time it began heeling. Given the vessel's low freeboard, water washed onto the main deck, reaching the sill of the open engine room door, and downflooded into the engine room. The flooding overwhelmed the towboat's reserve buoyancy, causing the vessel to sink.

The NTSB determined that the probable cause of the flooding and sinking of the towing vessel *Savage Ingenuity* was the absence of company procedures requiring the closure of weather deck doors at all times while the vessel was under way, which resulted in rapid downflooding into the engine room when the vessel heeled while perpendicular to a strong current with the head of its tow pushed into a river bank.

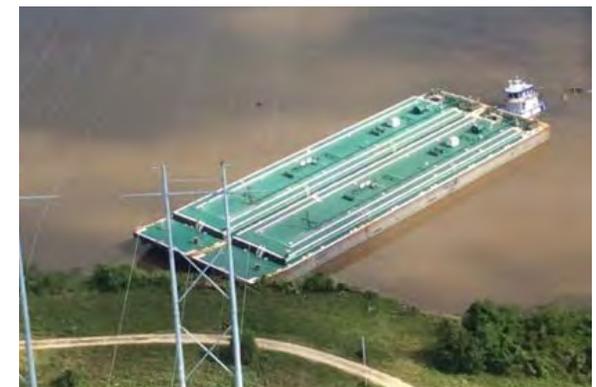
Figure 96. *Savage Ingenuity* and the two empty tank barges postaccident. PHOTO BY COAST GUARD

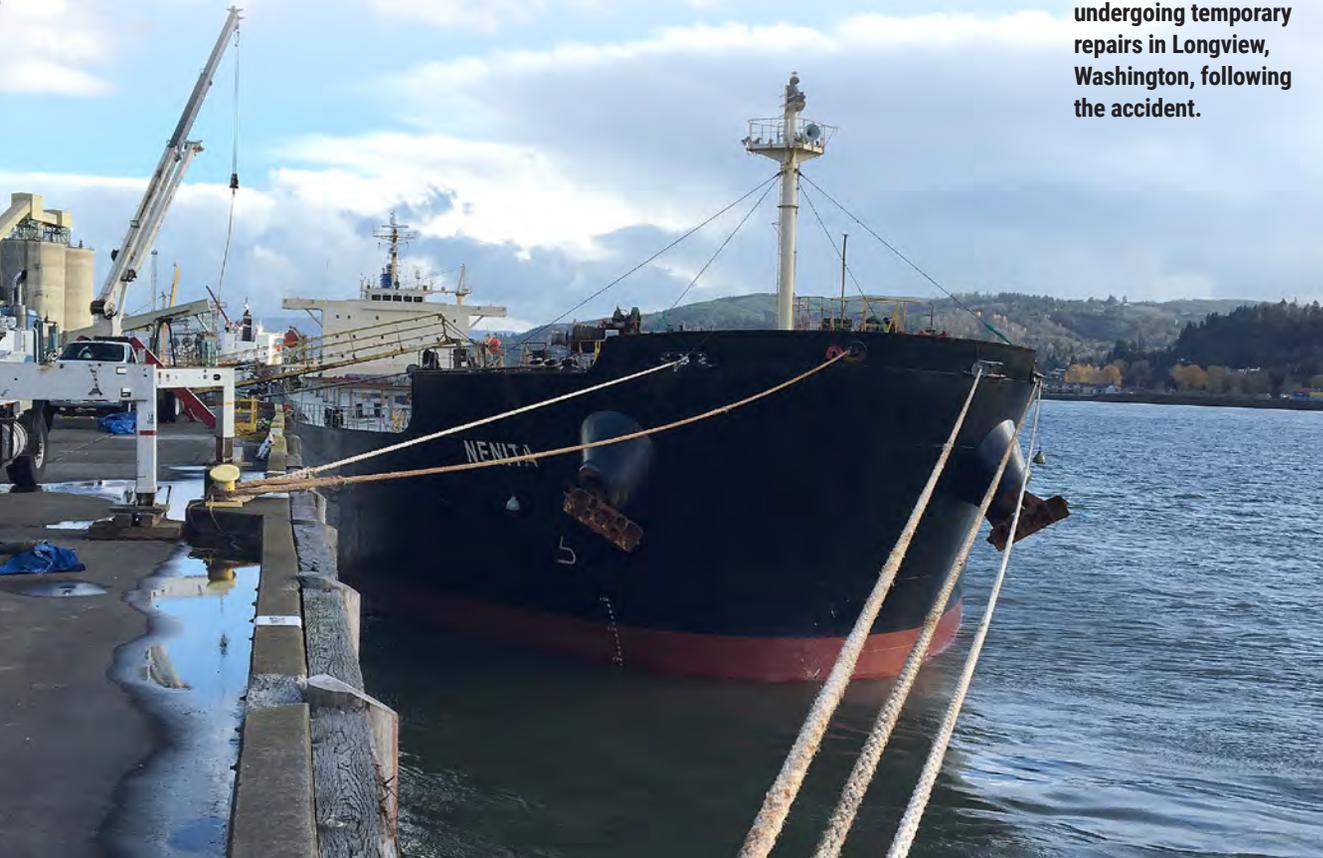
Figure 98. *Nenita* undergoing temporary repairs in Longview, Washington, following the accident.

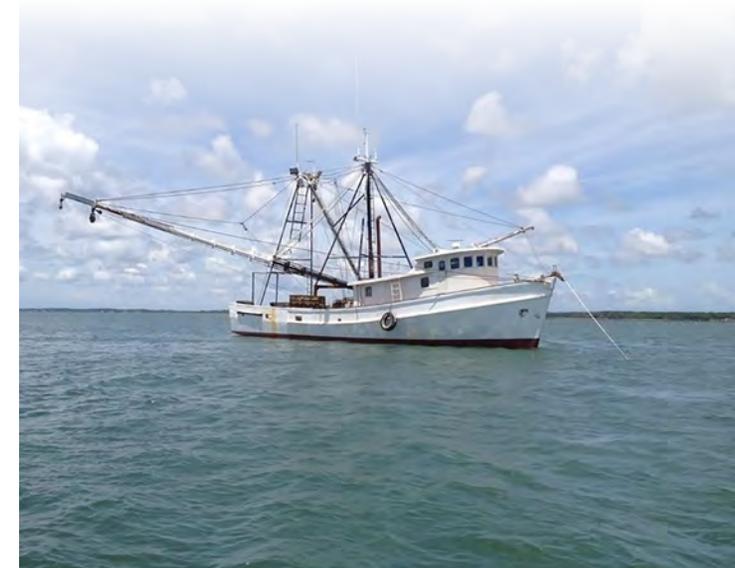
Figure 102. *Southern Bell* moored; location and date unknown. PHOTO COURTESY OF PHUONG HUYNH

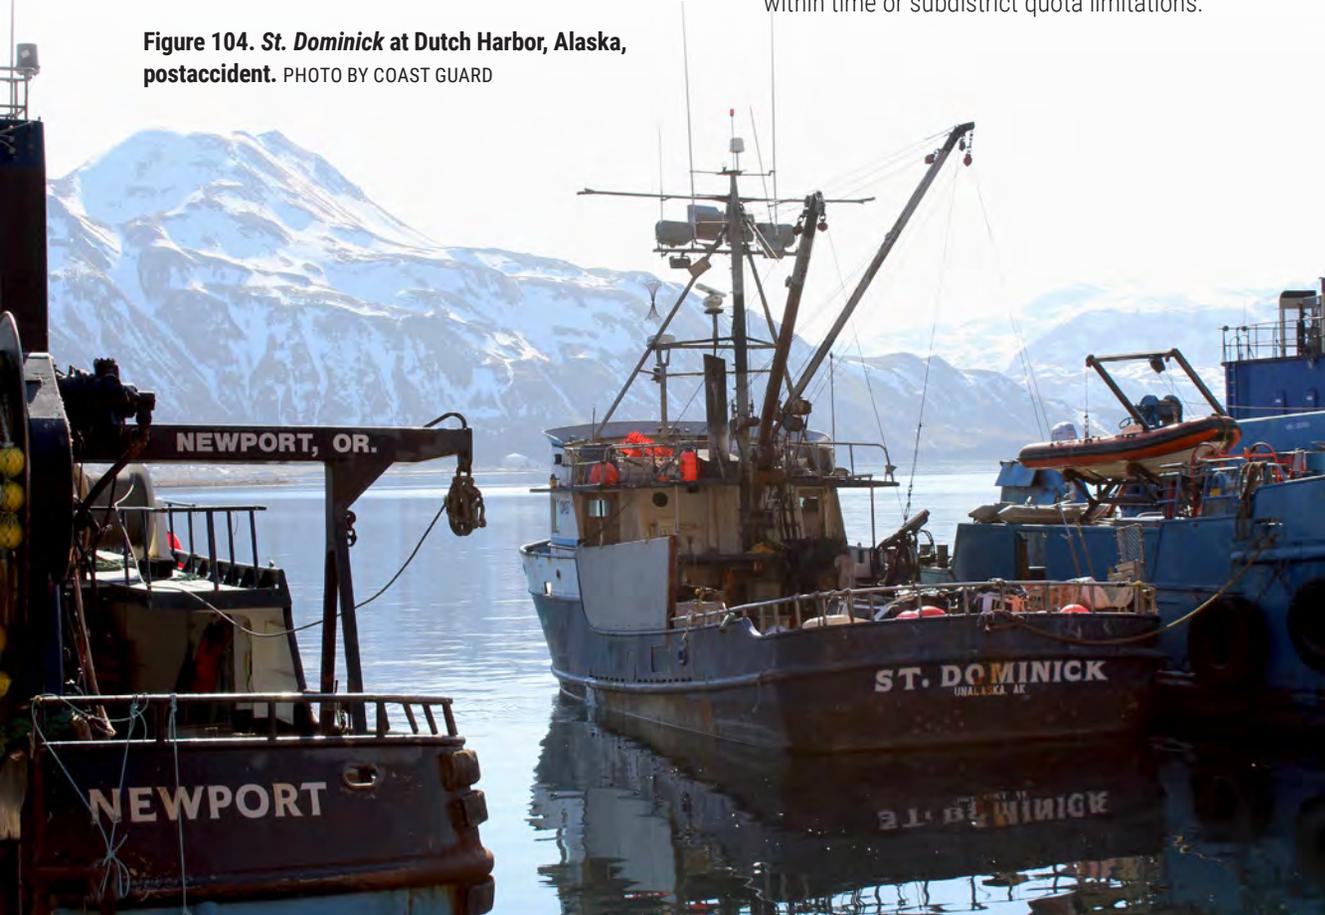
Figure 104. *St. Dominick* at Dutch Harbor, Alaska, postaccident. PHOTO BY COAST GUARD

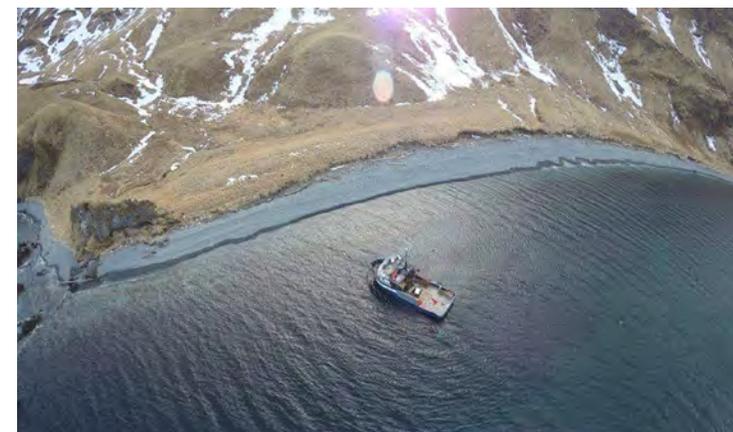
Figure 105. *St. Dominick* aground. PHOTO BY COAST GUARD

The NTSB determined that the probable cause of the grounding of the *St. Dominick* was the captain's failure to monitor the vessel's track as a result of his fatigue due to an accumulated sleep deficit. Contributing to the accident was the nature of the derby-style fishing that the *St. Dominick* was engaged in and the captain's failure to properly set the bridge watch alarm.

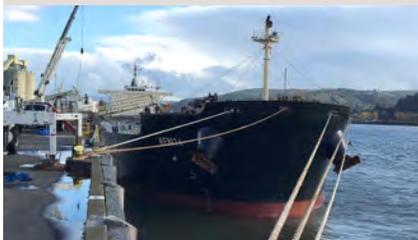
Cooling Water Chemistry

Maintaining proper water chemistry in engine cooling water systems reduces corrosion, scale, and the formation of deposits, which ensures effective cooling (heat transfer) to satisfy the system's operating requirements. Mariners should conduct testing per the manufacturer's recommended schedule, ensure levels of treatment are correct, and maintain water quality within specified limits. Insufficient cooling water maintenance may result in increased corrosion, clogging of cooling water passages, or, ultimately, the failure of equipment.

Improper cooling water chemistry may have been a factor in the *Nenita* accident.

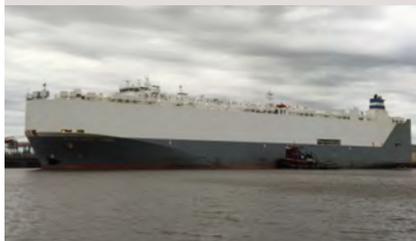
Threaded Fasteners and Components

Failure to tighten fasteners on diesel engines to the manufacturer's recommended torque settings was the cause of numerous accidents the NTSB has investigated over the past several years. Undertorquing a fastener may cause excess vibration or allow the fastener to come loose, while overtorquing may lead to failure of the fastener or the machinery component being secured. When installing fasteners, mariners should use a calibrated torque wrench and follow the manufacturer's recommended tightening guide and torque values.

Improperly torqued fasteners and components were factors in the *Nenita* and *Alliance St. Louis* accidents.

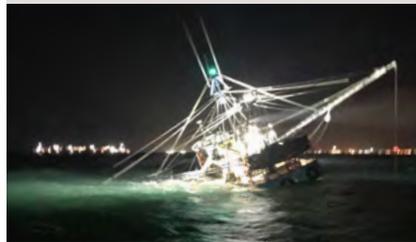
Recognizing Metal Fatigue in Propeller Shafting

Shearing of the propeller shaft can be a catastrophic casualty to a vessel. If the sheared shaft backs out of the stern tube, the resulting opening may allow water ingress that exceeds the vessel's bilge pumping capacity. Vessel owners and operators should be aware of the limitations of visual inspections in determining the condition of shafting and should consider the use of periodic non-destructive testing as a tool to identify metal fatigue.

Metal fatigue in the propeller shaft was likely a factor in the *Ben & Casey* accident.

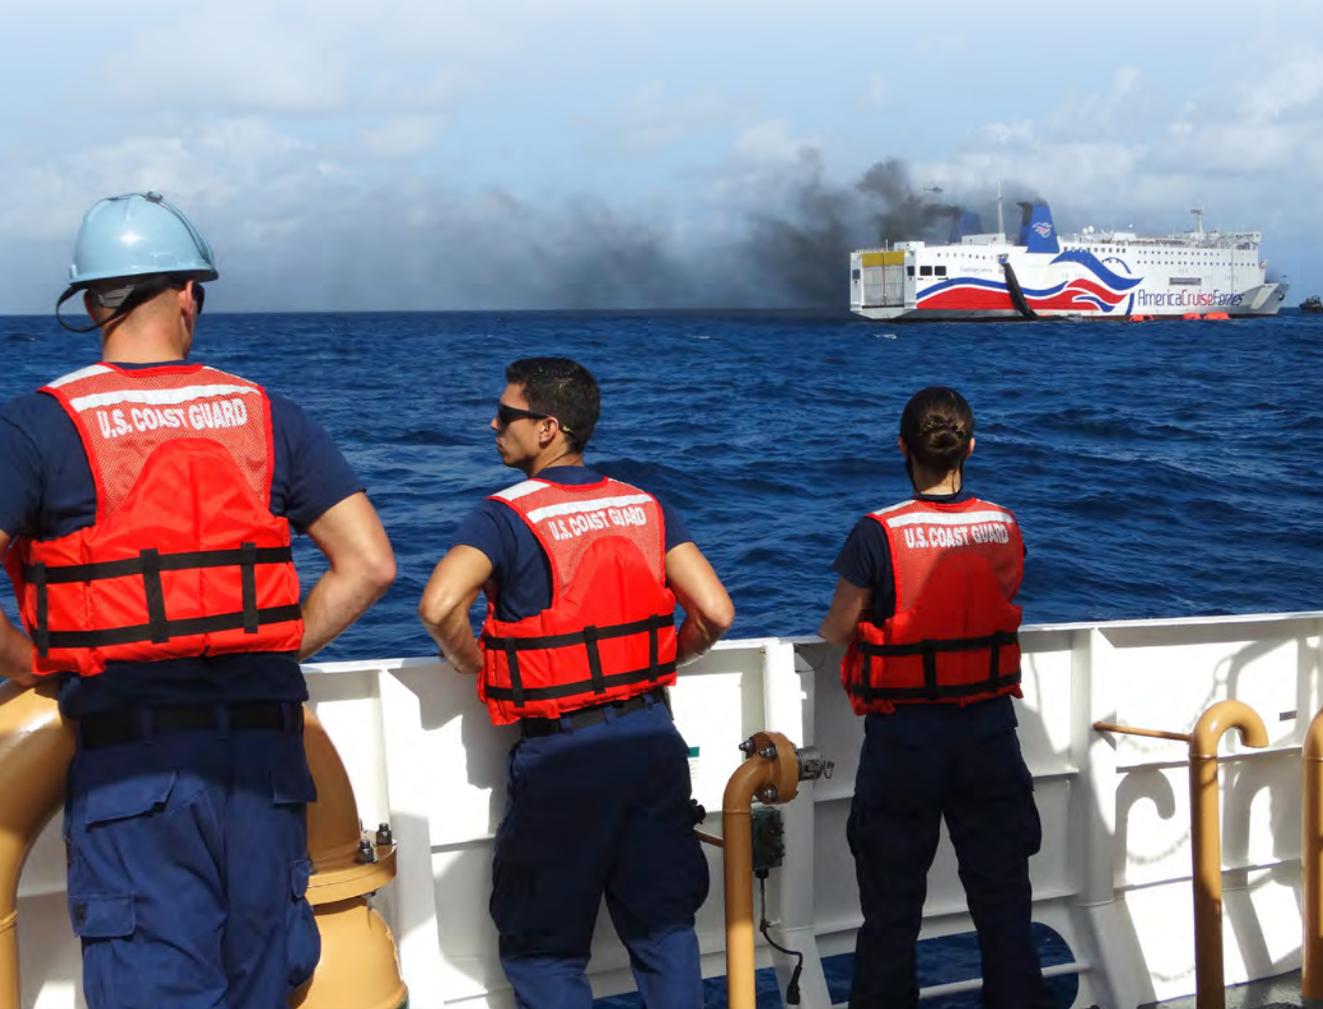
Figure 107. Coast Guard personnel engaged in the evacuation of passengers of the *Caribbean Fantasy* that caught fire near San Juan, Puerto Rico (see page 38).
